Ears and Eyes

With Pictures

Ears and Eyes is a searchable database of cases of physical surveillance devices (microphones, cameras, location trackers...) hidden by law enforcement and intelligence agencies to surveil people or groups engaged in subversive activities.

Part 2/2

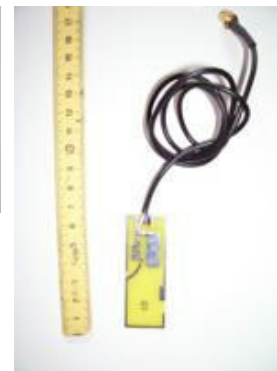
Second mobile phone

Microphones were found in a car. The device was located **in the car ceiling**. It was connected to the car interior light power supply. It consisted in a modified mobile phone, an antenna and two microphones.

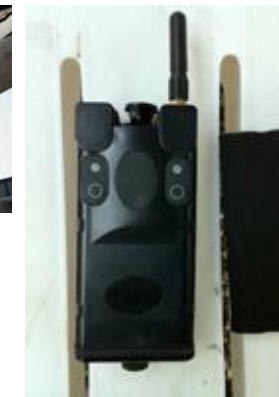
First tracker, in its sleeve

A **GPS tracker and microphones** were found in a car. The device was located **in a plastic container (badly) stuck under the roof**. It contained two boxes, both of which included a SIM card. From there wires went out, through a hole, up to under the back seats. There were two

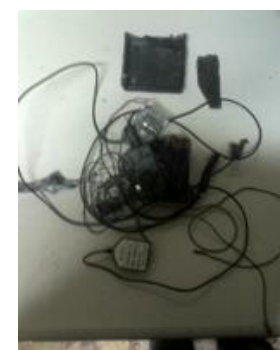
Overall view of the device

A **GPS tracker** was found on a car. Shortly after this first tracker was removed, a **second GPS tracker** was found on the same car. The first tracker was **attached with magnets to the wheel well of the car's spare tire**. It was in a fabric sleeve. The second tracker, of model “Sendum PT200”, was **attached with a magnet**. It included a 3.6 V lithium battery and was able to communicate on the mobile phone network.

microphones along the seat belt canal: the first at the driver's height, the second at the height of the levers used to adjust the seat, next to the back seats. The antenna was behind the back seat. Finally, still coming from these two boxes, a wire went through the car doors to reach the car fuse box.

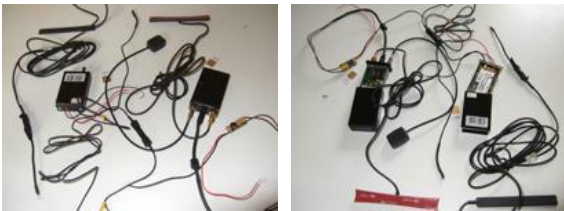
Two microphones and a GPS tracker were found in a car. They were located **in the car ceiling**. The device included SIM cards, a transformer, and antennas with a printed circuit board. The microphones were pointed towards the front seats.

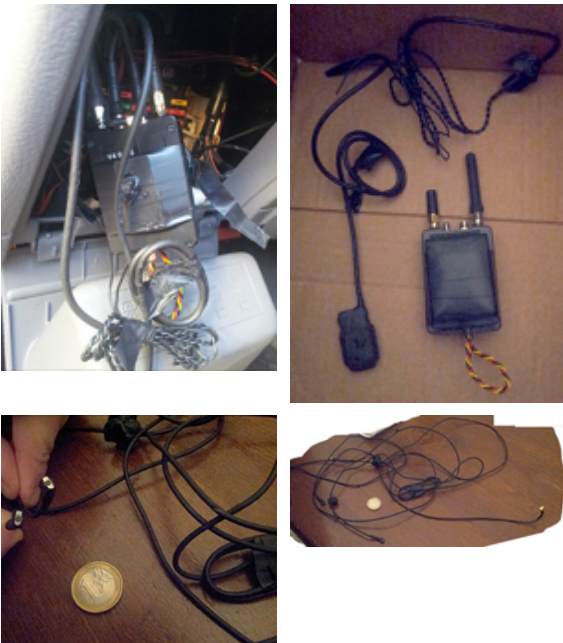
Microphones and a GPS tracker were found in a car. They were located **in the fuse box**. The car had been having electrical problems (the battery had discharged twice in a month, sign of an abnormal electricity consumption), presumably because of the devices.

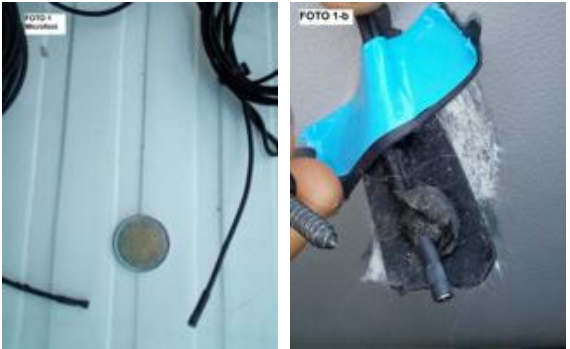
Two microphones and a GPS tracker were found in a car. There was also a device equipped with an antenna, a SIM card and a 16 GB memory card. The microphones were located **under the upholstery of the car roof** and the wires reached the power supply **through the car door**. The power cable was **connected to the fuse box** and to other wires located **under the dashboard**. The magnetized GPS and a thing with

an antenna and cards were hidden **behind the speedometer**. Everything had been seemingly installed in the car more than a year before the discovery and the microphones were recording even when the car engine was turned off, in a radius of several meters.

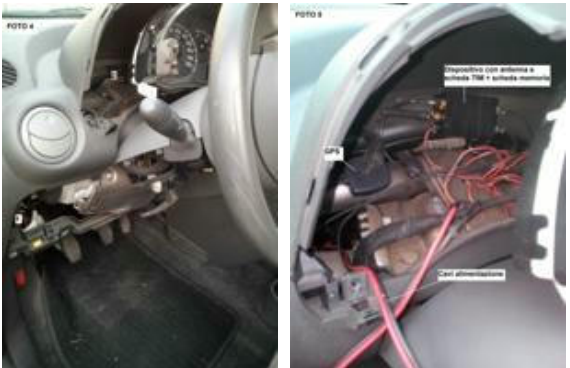
The device with an antenna connected to the microphones and the GPS. It also included a SIM and memory card.

1: behind the speedometer; 2: the fuse box.

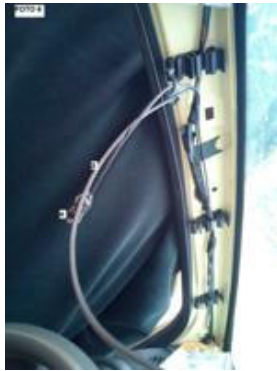
Microphones and their power cable

Counterclockwise from top: device with antenna, SIM and memory card; GPS; power cables.

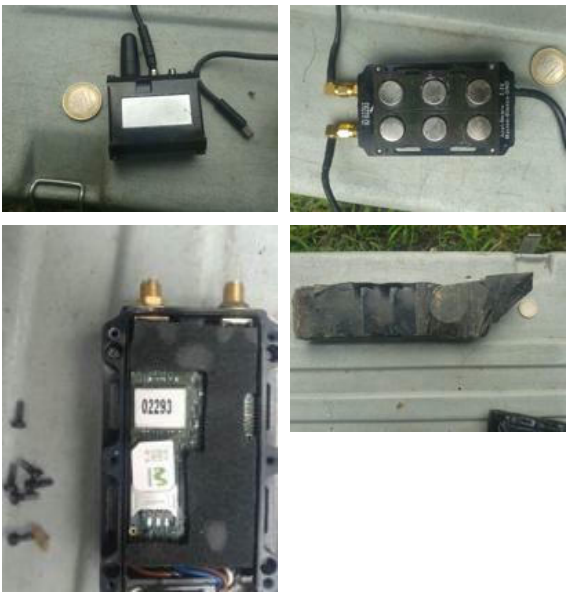
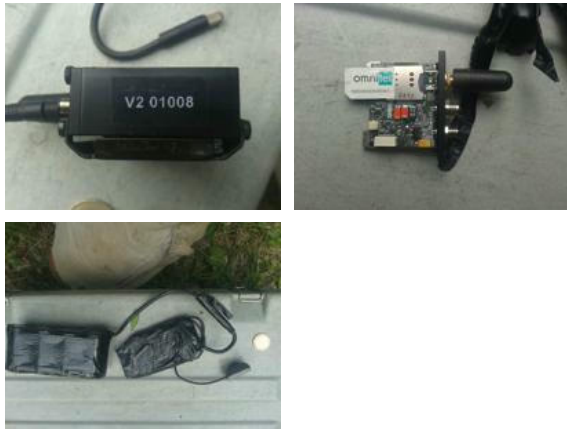
A **microphone** and **two GPS trackers** were found in a vehicle. A first tracker was **attached with a magnet to the rear bumper, on the right side**. The other tracker, along with the microphone, was located **in the air vents located between the windscreen flap and the windscreen**. The first tracker included a SIM card and an accumulator made of five 3.6 V lithium batteries connected in a series. The other tracker was equipped with a SIM card.

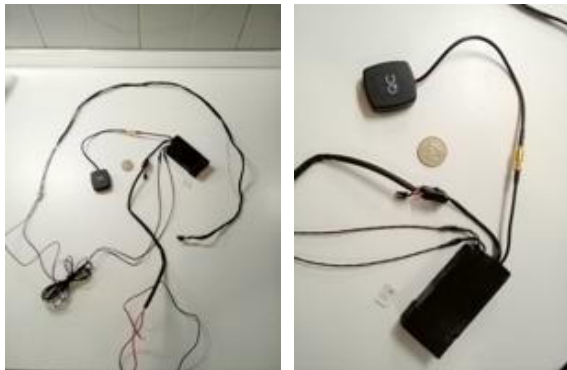
A **tracking device** and **two microphones** were found in a car. The tracking device was **connected to the power supply of the control unit underneath the steering wheel on the left side**. It was **attached with a magnet, tape, and insulating fabric**. The microphones were located **at the end of a long cable running from the inside of the internal side pillar linings of the windscreen to the underside of the roof of the car**. The tracking device used the GLONASS positioning system, and consisted of an antenna connected to a multi-frequency receiver box containing a micro SIM card.

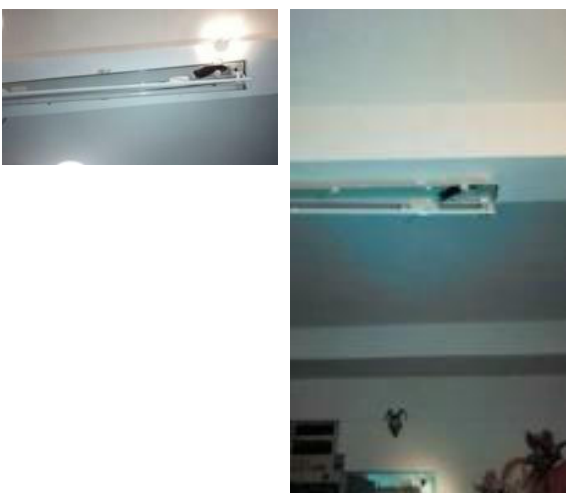
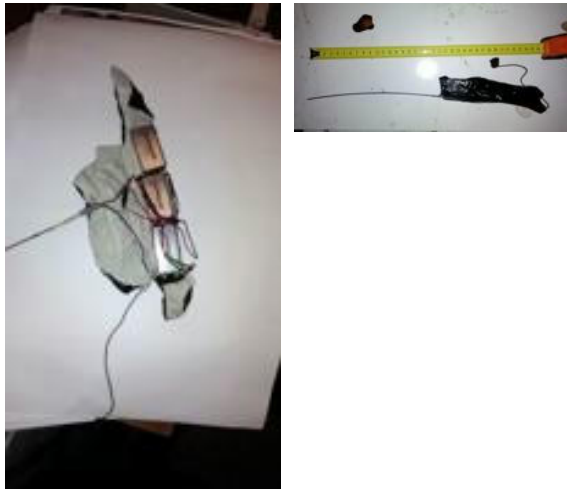
A **microphone** was found in a building. It was located **inside a neon light attached to the ceiling**. It consisted in three 9-volts batteries, joined together with insulating tape, with a microphone and antenna at each end.

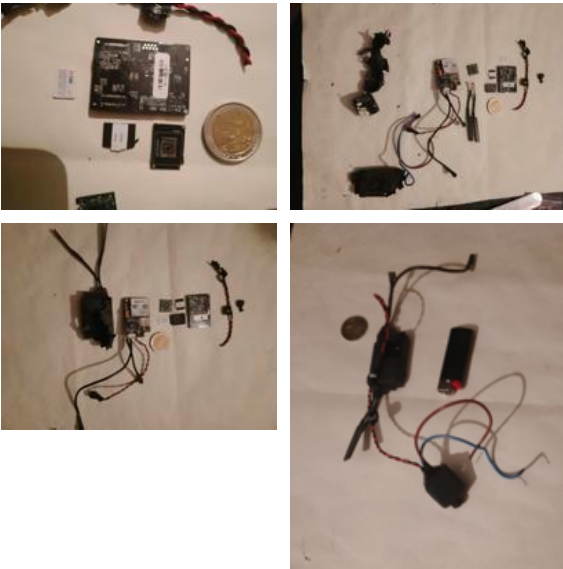
A **microphone** was found in a building. It was located **inside a power outlet**. It was equipped with a microphone, two antennas, a SIM card, a memory card and a battery.

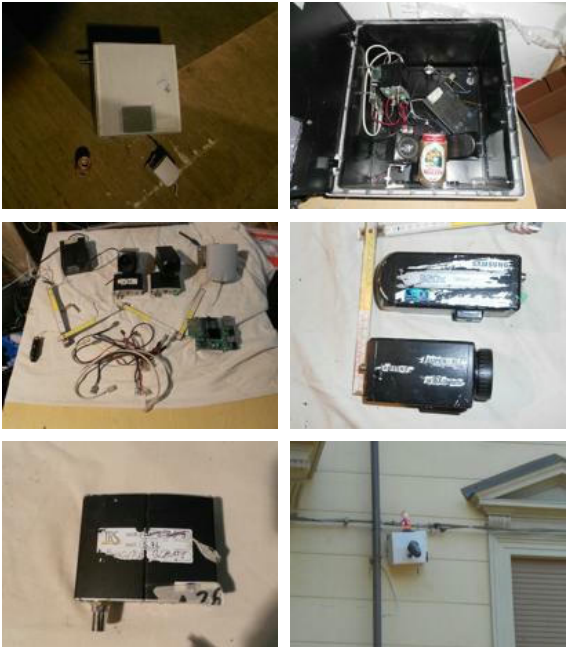
The box where the cameras were found

The logo of the Italian company Gruppo TRS, which was bought in 2012 by the Italian company Atet, is visible on the pictures of the cameras. This suggests that the cameras were supplied by the Italian company **Atet**.
