Ears and Eyes

With Pictures

Ears and Eyes is a searchable database of cases of physical surveillance devices (microphones, cameras, location trackers...) hidden by law enforcement and intelligence agencies to surveil people or groups engaged in subversive activities.

Part 2/2: Italy–Unknown country

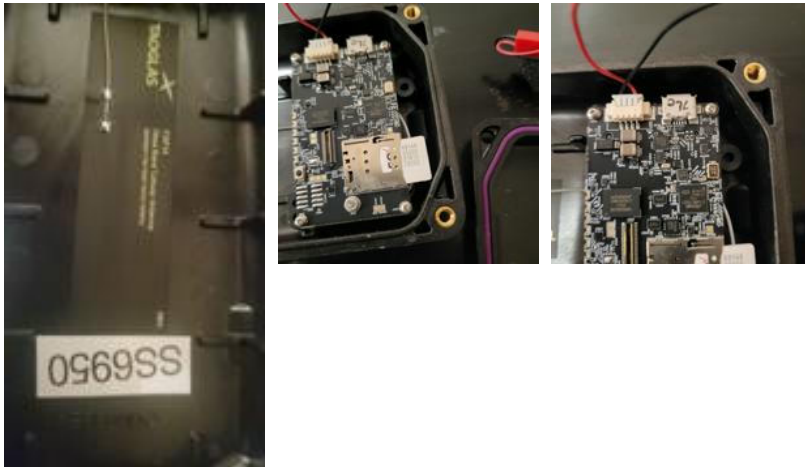
On the left: modified version of the phone's largest circuit board (with surveillance device) without the battery pack. On the right: unmodified version.

A **surveillance device** was found **inside the desktop phone** of a journalist seemingly targeted for their support to the news organization Wikileaks. The phone, a “Cryptophone” based on the “Snom 870” desktop phone, enabled encrypted voice communications with other Cryptophones. The surveillance device included a battery pack and a shielded module with several electronic components. It was able to record what was said on the phone and could be triggered remotely through radio frequencies to send the recorded data. Components of the phone were modified to install the surveillance device. The device was probably installed by the CIA (Central Intelligence Agency).

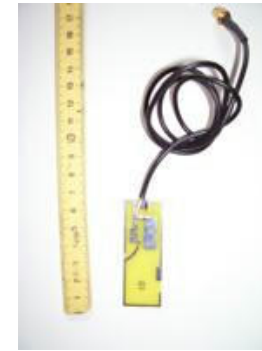
Second mobile phone

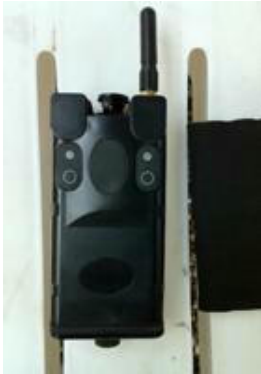
First tracker, in its sleeve

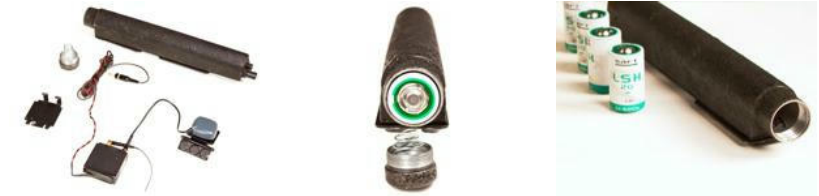
Overview of the device before it was disassembled

Tip of the battery pack

The batteries

A **GPS tracker** was found under a car. It was located **under the car rear bumper**. It included a battery pack, a GPS antenna, a transmitter-receiver module and powerful magnets. It was installed by the FBI (Federal Bureau of Investigation).

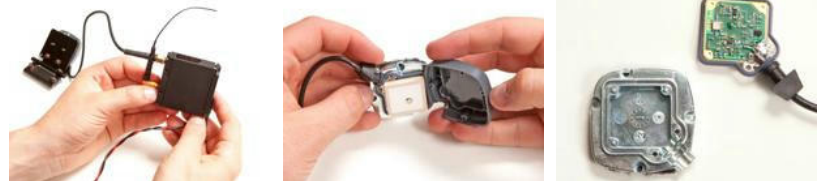
Transmitter-receiver module (closed)

GPS antenna

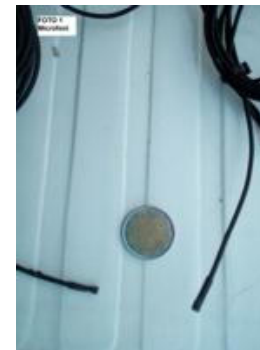
The microphones

Two microphones and a GPS tracker were found in a car. There was also a device equipped with an antenna, a SIM card and a 16 GB memory card. The microphones were located **under the upholstery of the car roof** and the wires reached the power supply **through the car door**. The power cable was **connected to the fuse box** and to other wires located **under the dashboard**. The magnetized GPS and a thing with an antenna and cards were hidden **behind the speedometer**. Everything had been seemingly installed in the car more than a year before the discovery and the microphones were recording even when the car engine was turned off, in a radius of several meters.

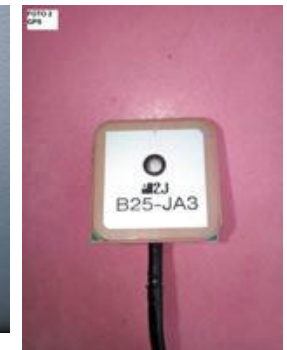
The GPS

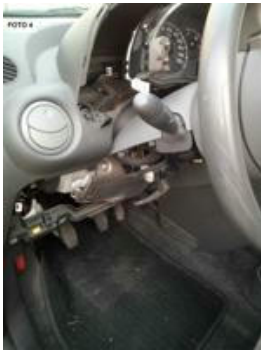
1: behind the speedometer; 2: the fuse box.

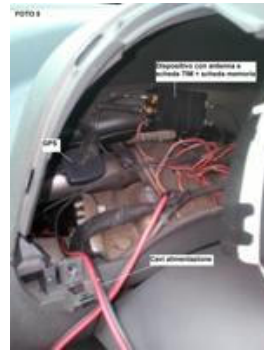
Counterclockwise from top: device with antenna, SIM and memory card; GPS; power cables.

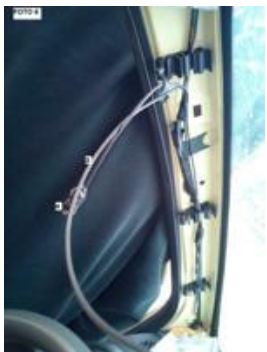
Microphones and their power cable

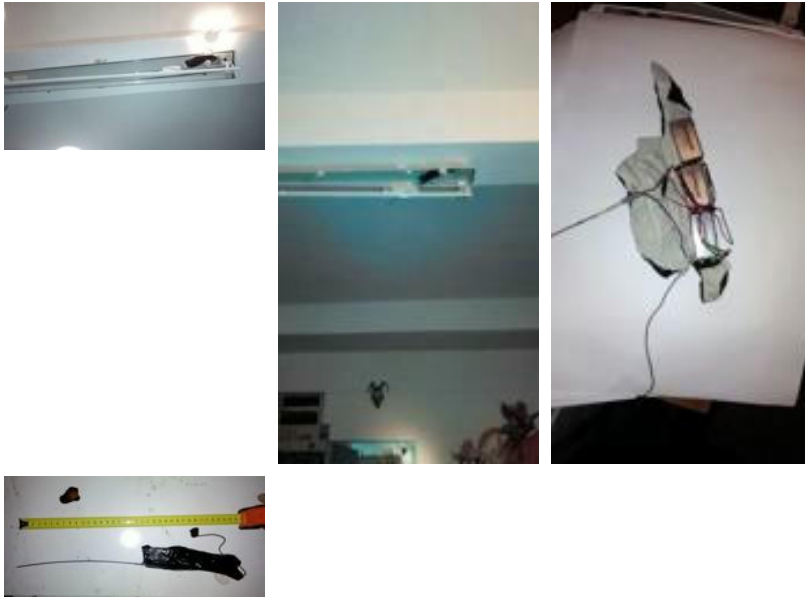
A **microphone** was found in a building. It was located **inside a neon light attached to the ceiling**. It consisted in three 9-volts batteries, joined together with insulating tape, with a microphone and antenna at each end.
