Ears and Eyes

With Pictures

Ears and Eyes is a searchable database of cases of physical surveillance devices (microphones, cameras, location trackers...) hidden by law enforcement and intelligence agencies to surveil people or groups engaged in subversive activities.

Part 2/2 Italy–Unknown country

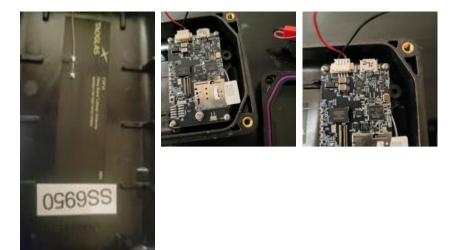
Modified version of the phone's largest circuit board (with surveillance device). The battery pack (in blue) and the shielded module (in light brown) are part of the surveillance device. Modified version of the phone's largest circuit board, with the cover of the shielded module removed. On the left: modified version of the phone's largest circuit board (with surveillance device) without the battery pack. On the right: unmodified version.

A surveillance device was found inside the desktop phone of a journalist seemingly targeted for their support to the news organization Wikileaks. The phone, a "Cryptophone" based on the "Snom 870" desktop phone, enabled encrypted voice communications with other Cryptophones. The surveillance device included a battery pack and a shielded module with several electronic components. It was able to record what was said on the phone and could be triggered remotely through radio frequencies to send the recorded data. Components of the phone were modified to install the surveillance device. The device was probably installed by the CIA (Central Intelligence Agency).

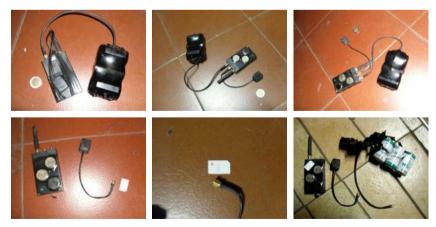
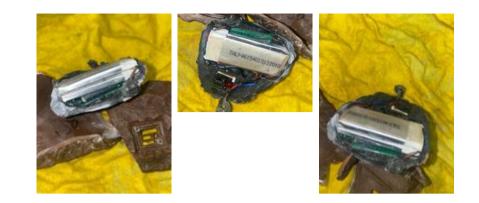
A GPS tracker was found in a car. It was located in the rear bumper, attached to the car body with magnets. It consisted in removable batteries and a SIM card.

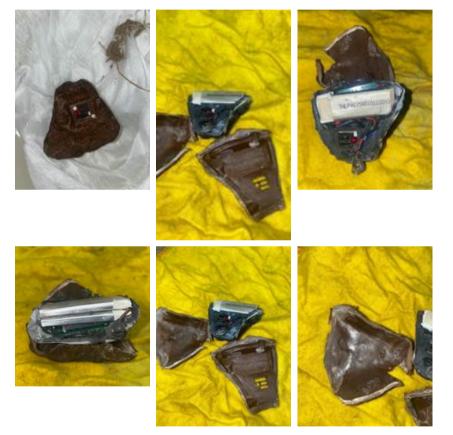
A listening device was found outside. It was disguised as a rock. It contained two microphones.

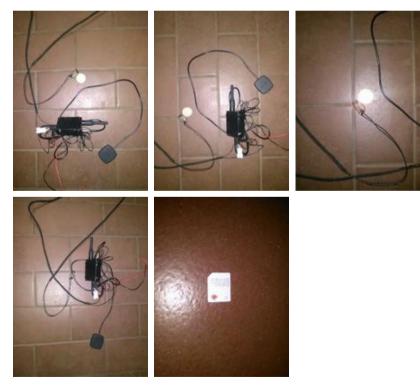
A microphone was found in a car. It was located in the upholstery of the vehicle roof. The device wires were hidden in the isolation case. The device was connected to the car electrical system, so that it turned on when the car started. It included a SIM card.

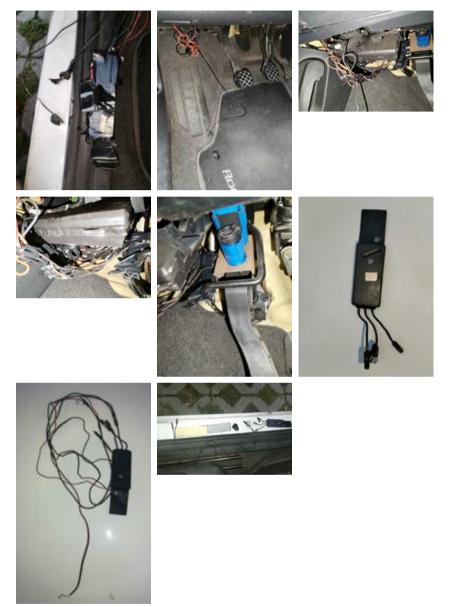
Trieste, July 2023

A **microphone** was found in a car. It was hidden **inside the vehicle**. The night before the device was found, one of the car's windows was broken, a few things inside it were stolen, and four men were seen tampering with the vehicle—the theft was presumably a cover-up for the device installation.

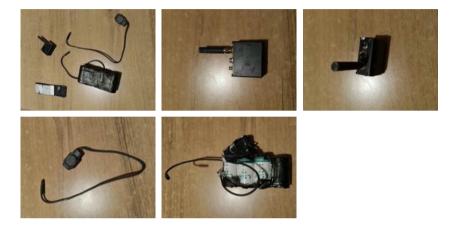
A tracking device was found under a car. The battery-powered device was attached with strong magnets under the car body, in the rear, just past the bumper.

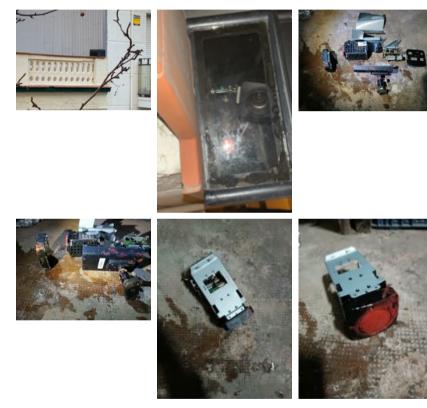
A camera was found in front of a house. It was located inside a black box, on the roof of a restaurant located in front of the house.

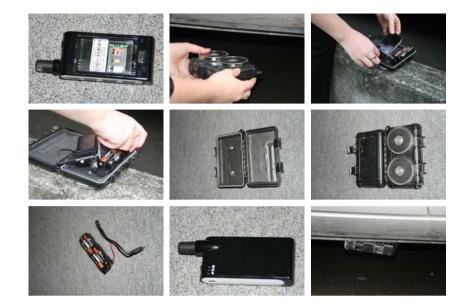
Modena, December 2015

A microphone was found in a building. It was located inside a neon light attached to the ceiling. It consisted in three 9-volts batteries,

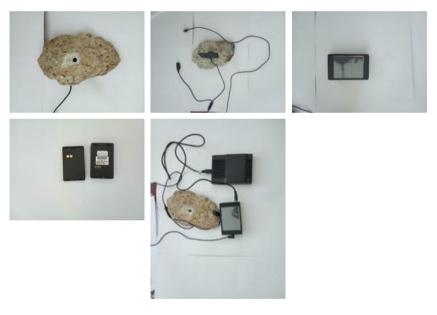
The pictures of the device show that the device included a digital video recorder of model "DK-PV500E", marketed by the Italian company DSE (Digital Surveillance Equipment). This suggests that the device was supplied by the Italian company **DSE**.

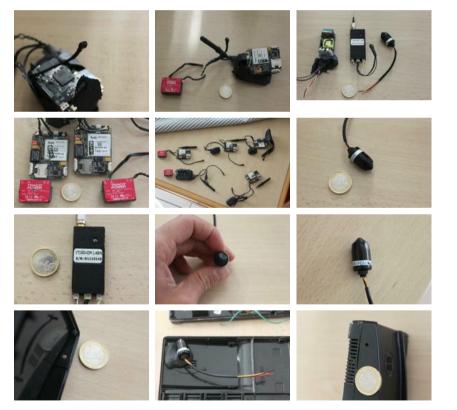
Six microphones and a camera were found in a house. The microphones were located in electrical outlets and switch cases, one above the intercom in the corridor, two other in the living-room, and the three last ones in bedrooms. The camera was located inside the intercom in the corridor and connected to the microphone above it. Each microphone was equipped with a battery, and, except for the one in the corridor, with a SIM card and a memory card. The camera lens could observe through a small hole already present in the intercom structure and slightly modified to fit the device.

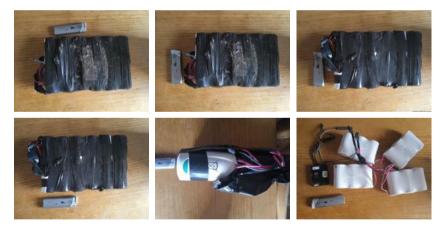
A microphone was found in a house.
