# Ears and Eyes

With Pictures

*Ears and Eyes* is a searchable database of cases of physical surveillance devices (microphones, cameras, location trackers...) hidden by law enforcement and intelligence agencies to surveil people or groups engaged in subversive activities.

Part 2/2

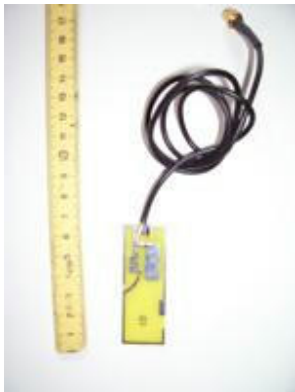
Second mobile phone

**Microphones** were found in a car. The device was located **in the car ceiling**. It was connected to the car interior light power supply. It consisted in a modified mobile phone, an antenna and two microphones.

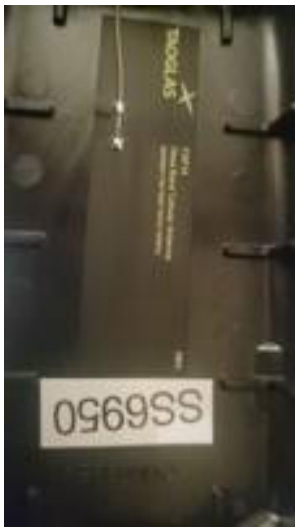
A **GPS tracker and microphones** were found in a car. The device was located **in a plastic container**

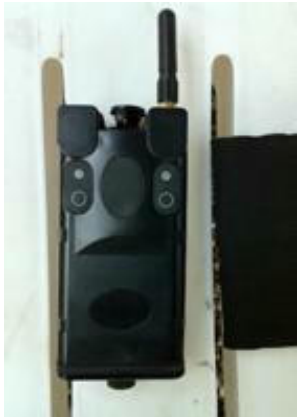
First tracker, in its sleeve

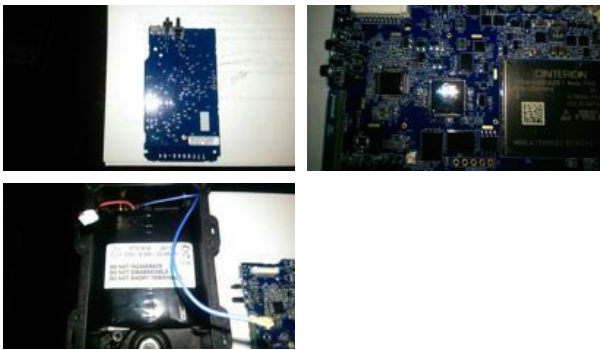
A **tracking device** was found on a truck. It was **attached with a magnet to the frame of the truck**.

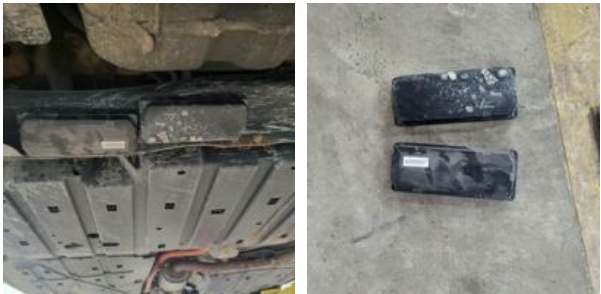
A **tracking device** was found under the car of someone who had been arrested two days earlier on an outstanding warrant. It was **attached under the rear axle of the car with strong magnets**. The device included a battery, a cellular antenna and a SIM card.

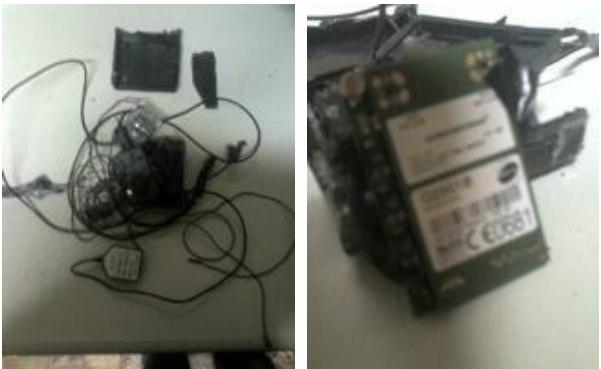
**(badly) stuck under the roof**. It contained two boxes, both of which included a SIM card. From there wires went out, through a hole, up to under the back seats. There were two microphones along the seat belt canal: the first at the driver's height, the second at the height of the levers used to adjust the seat, next to the back seats. The antenna was behind the back seat. Finally, still coming from these two boxes, a wire went through the car doors to reach the car fuse box.

Overall view of the device

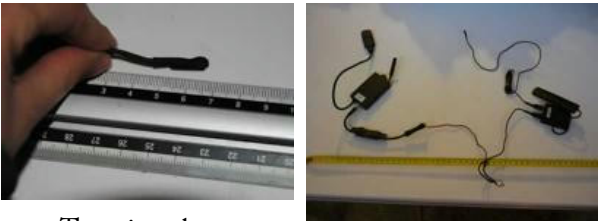
A **GPS tracker and a microphone** were found in a car. The device was located **between the car**

**body and the interior coating, attached with two magnets**. It was connected to the car power supply by the car interior light wires. It consisted in a modified mobile phone, an antenna, a GPS and a microphone.

The microphone

The whole device

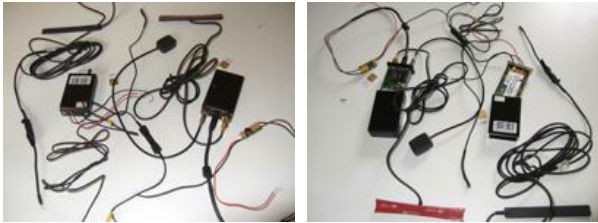
**Two microphones and a GPS tracker** were found in a car. They were located **in the car ceiling**. The device included SIM cards, a transformer, and antennas with a printed circuit board. The microphones were pointed towards the front seats.

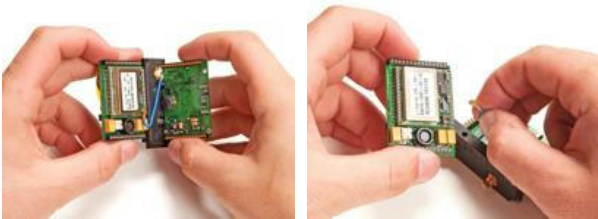
**Microphones and a GPS tracker** were found in a car. They were located **in the fuse box**. The car had been having electrical problems (the battery had discharged twice in a month, sign of an abnormal electricity consumption), presumably because of the devices.

Transmitter-receiver module (open)

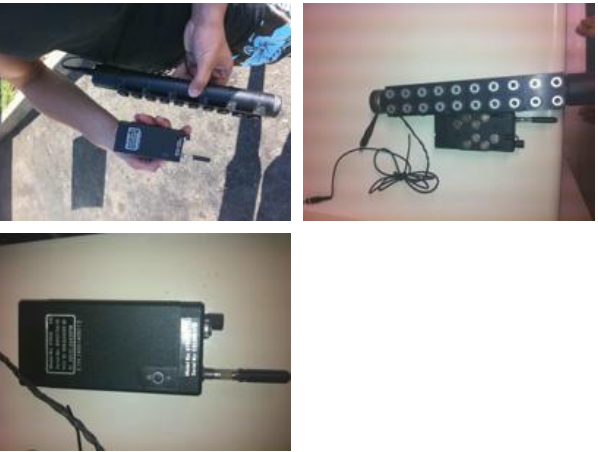
A **GPS tracker** was found on a car. It was **attached with a magnet**. Its model was “Orion Guardian ST820” and it included a transmitter and a battery pack.

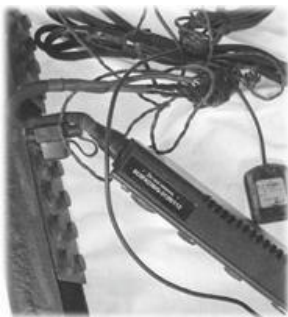
GPS trackers were found under three cars. They were **attached by powerful magnets behind the rear bumpers on the driver's side**. Each one contained a battery pack made of four lithium D cell batteries, a GPS antenna, a cellular antenna and a main component box. The component box contained a GPS receiver, a computer chip and a cellular modem. All the components were wired together. The trackers were probably installed by the FBI (Federal Bureau of Investigation).

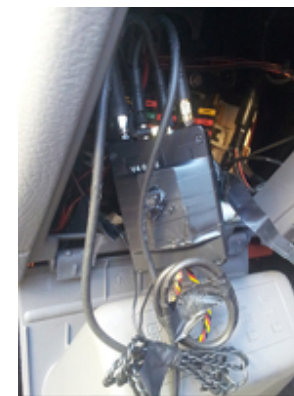
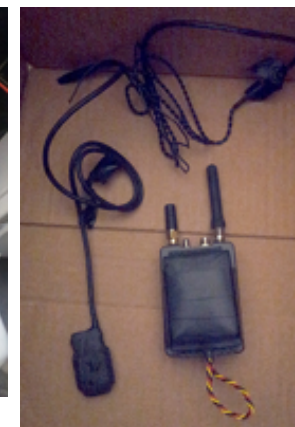
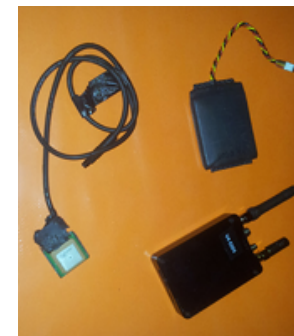
A **GPS tracker** was found under a car. It was located **under the car rear bumper**. It included a battery pack, a GPS antenna, a transmitter-receiver module and powerful magnets. It was installed by the FBI (Federal Bureau of Investigation).

Transmitter-receiver module (open)

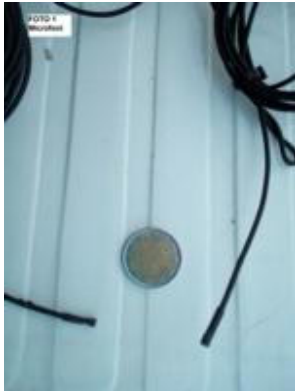
The microphones

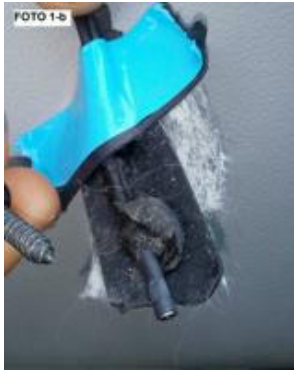
A microphone

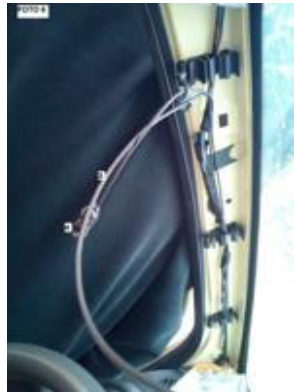
Microphones and their power cable

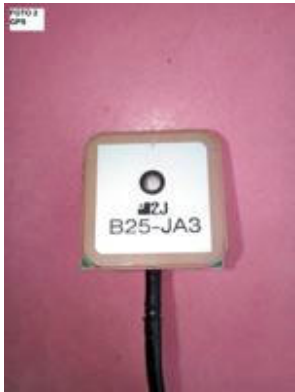
The GPS

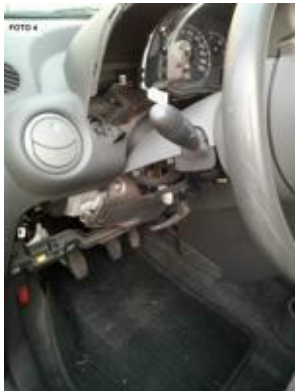
1: behind the speedometer; 2: the fuse box.

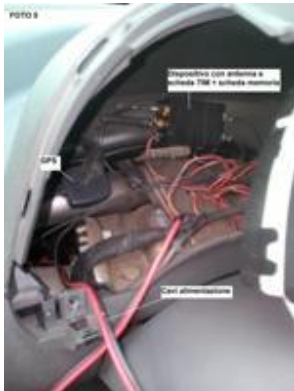
Counterclockwise from top: device with antenna, SIM and memory card; GPS; power cables.

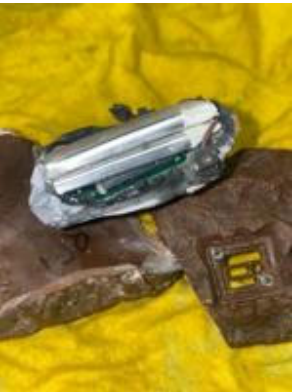
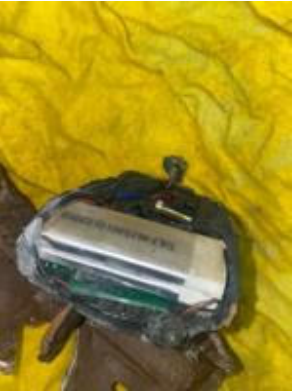
**Two microphones and a GPS tracker** were found in a car. There was also a device equipped with an antenna, a SIM card and a 16 GB memory card. The microphones were located **under the upholstery of the car roof** and the wires reached the power supply **through the car door**. The power cable was **connected to the fuse box** and to other wires located **under the dashboard**. The magnetized GPS and a thing with an antenna and cards were hidden **behind the speedometer**. Everything had been seemingly installed in the car more than a year before the discovery and the microphones were recording even when the car engine was turned off, in a radius of several meters.

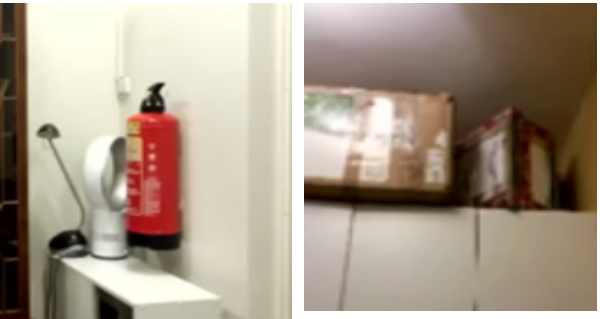
The microphone inside the fire extinguisher was equipped with an SD card and a battery which was changed every twelve hours. The microphone in the bathroom was connected to the electrical system of the building. The devices were installed by the Spanish company Undercover Global, officially in charge of the security at the embassy. Their installation appeared to have been ordered by the CIA (Central Intelligence Agency).

The fire extinguisher where a microphone was hidden

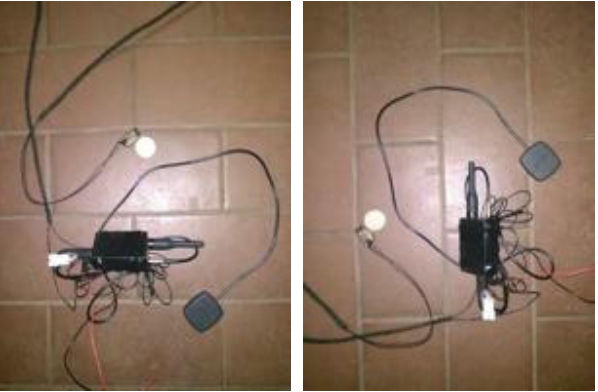
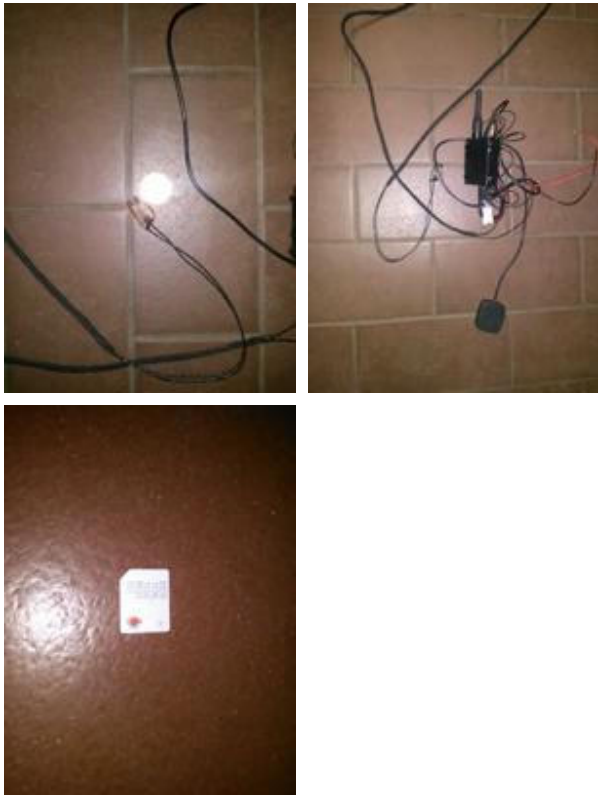
A **microphone** was found in a car. It was located **in the upholstery of the vehicle roof**. The device wires were hidden in the isolation case. The device was connected to the car electrical system, so that it turned on when the car started. It included a SIM card.

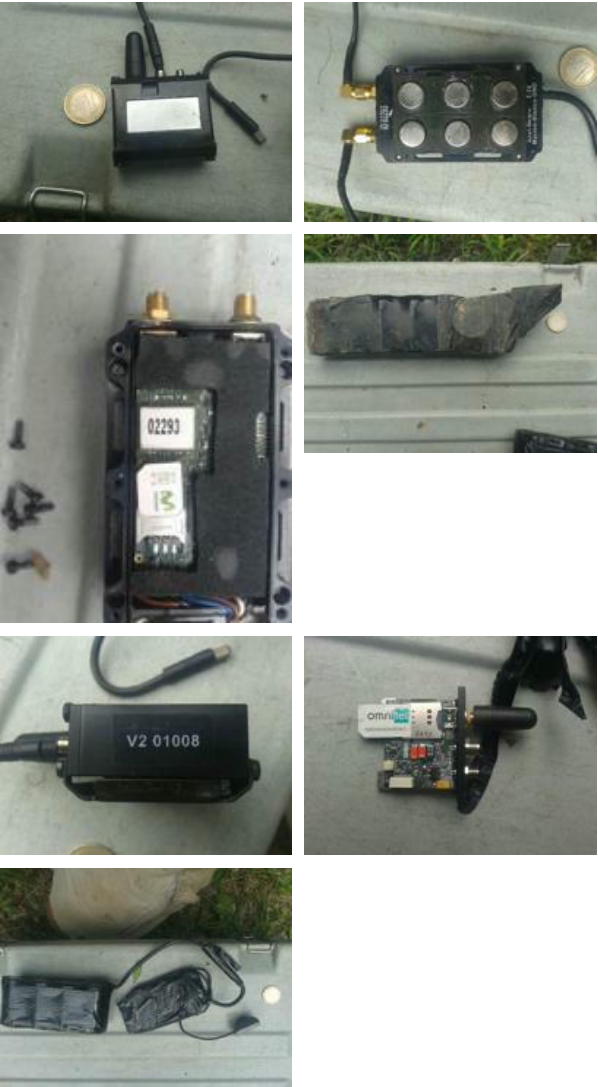
A microphone and two GPS trackers were found in a vehicle. A first tracker was **attached with a magnet to the rear bumper, on the right side**. The other tracker, along with the microphone, was located **in the air vents located between the wind-screen flap and the windscreen**. The first tracker included a SIM card and an accumulator made of five 3.6 V lithium batteries connected in a series. The other tracker was equipped with a SIM card.

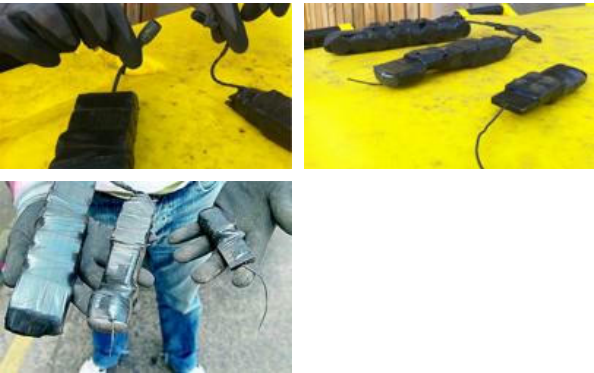
A **GPS tracker** and a **listening device** were found on the car of an Irish republican. Parts of the device—battery packs and a transmitter—were hidden **behind the car rear bumper**.

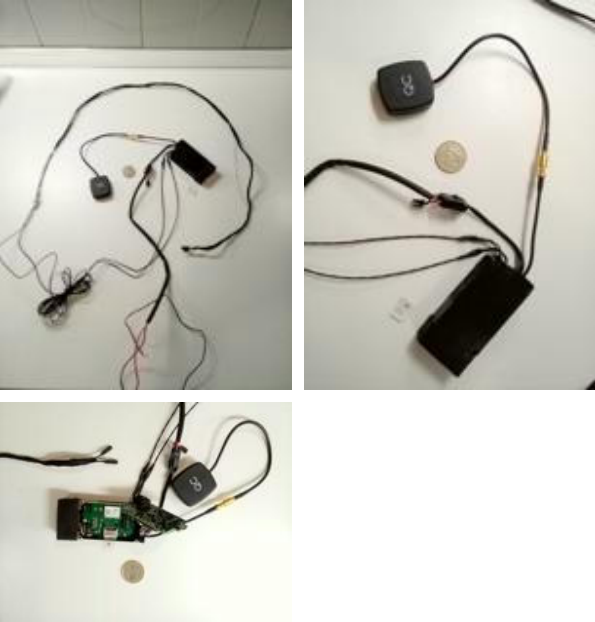
**pillar linings of the windscreen to the underside of the roof of the car**. The tracking device used the GLONASS positioning system, and consisted of an antenna connected to a multi-frequency receiver box containing a micro SIM card.

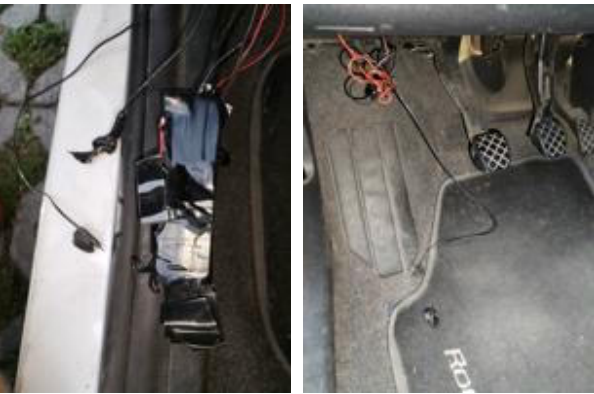
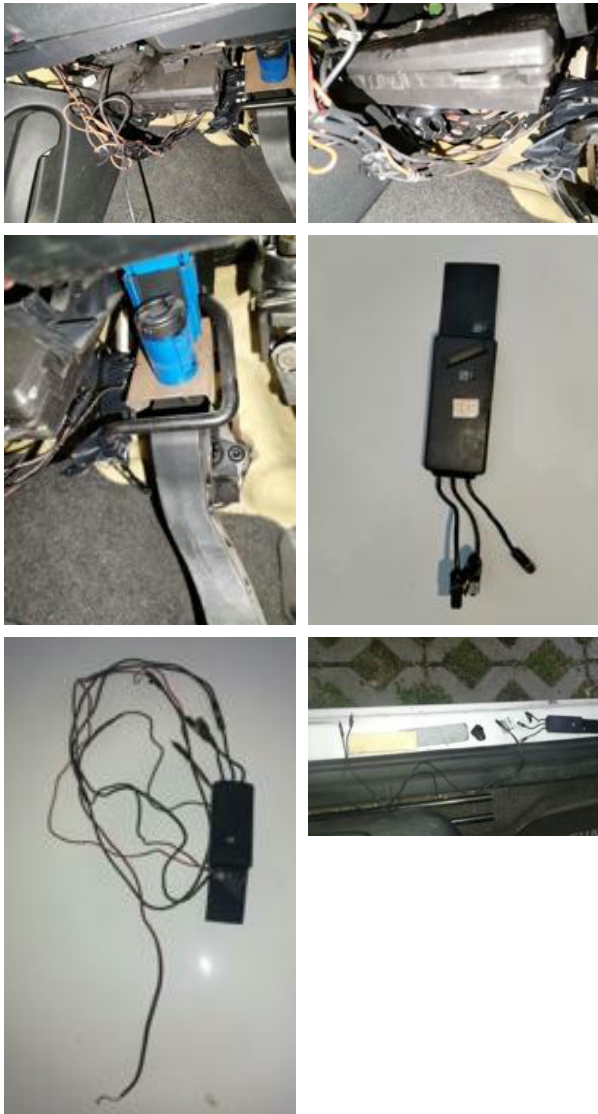
A **microphone** was found in a car. It was hidden **inside the vehicle**. The night before the device was found, one of the car's windows was broken, a few things inside it were stolen, and four men were seen tampering with the vehicle—the theft was presumably a cover-up for the device installation.

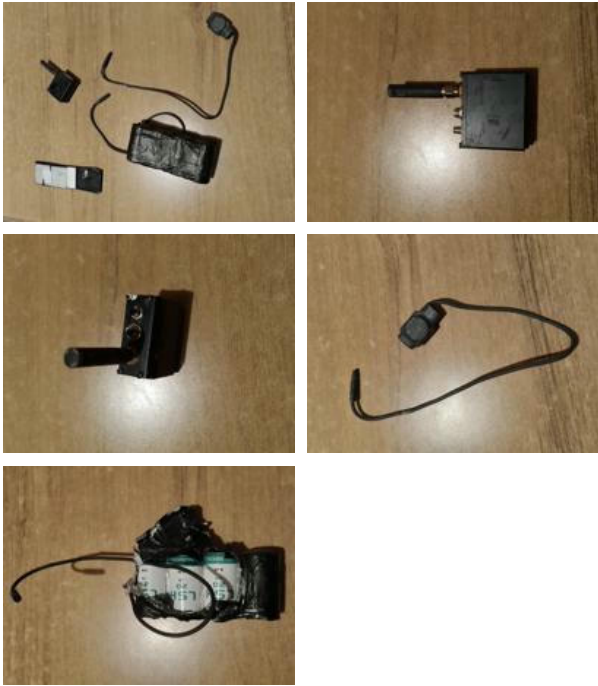
A **tracking device** was found under a car. The battery-powered device was **attached with strong magnets under the car body, in the rear, just past the bumper.**

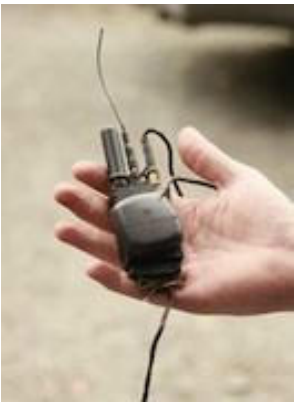
A **GPS tracker** was found under the car of an Irish republican. It was located **inside the car's rear bumper** and **attached to the vehicle with magnets**. Shortly after the device was discovered the car was seized by the police, and returned to the owner after a number of hours.

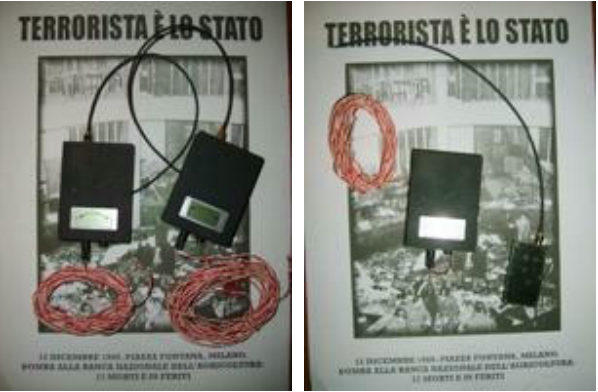
**Two receiver cases** were found in the entry corridor of a building. They were hidden **above a fake ceiling in the entry corridor**. They were connected to the phone line with telephone wires. They consisted in a main unit with a remote-controlled connector, a digital receiver showing the strength of the received signal, and antennas. The presence of the two receivers presumably meant that there were two emitting microphones in the building.

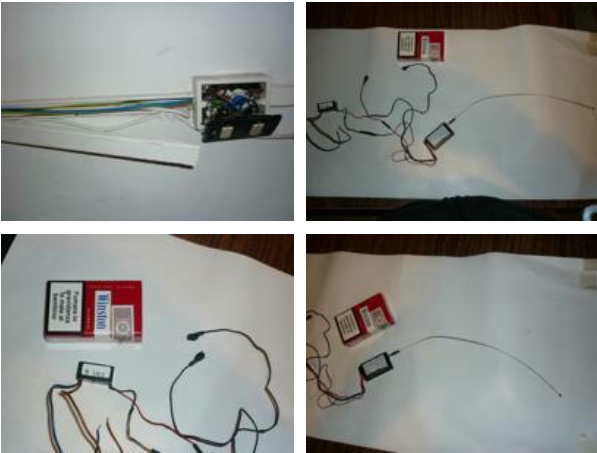
A **microphone** was found in a building. It was located **inside an electrical outlet**. It was a transmitter-receiver.

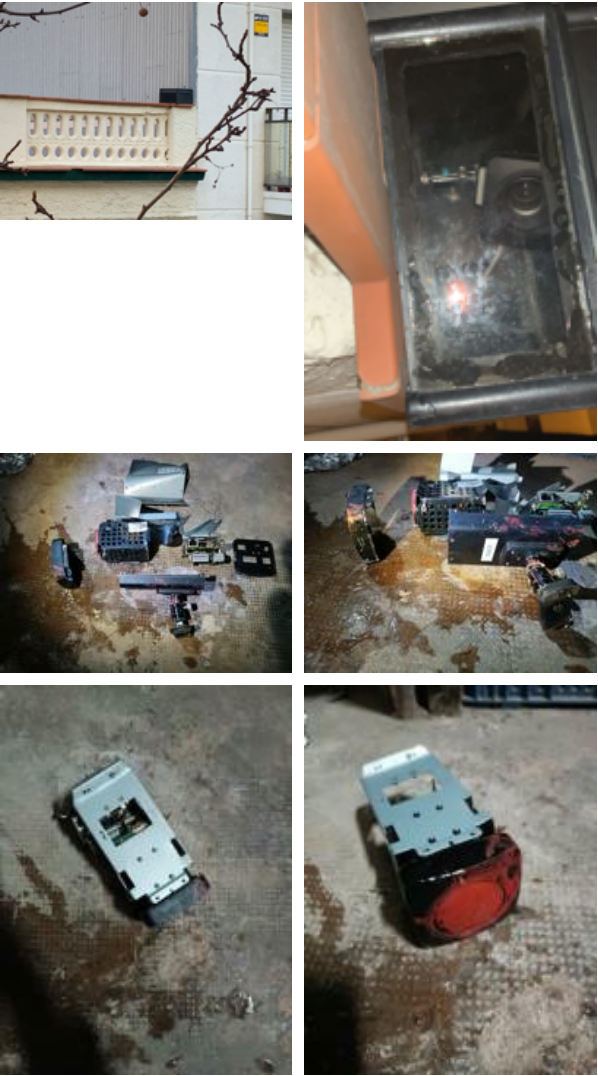
A **camera** was found in front of a house. It was located **inside a black box, on the roof of a restaurant located in front of the house**.

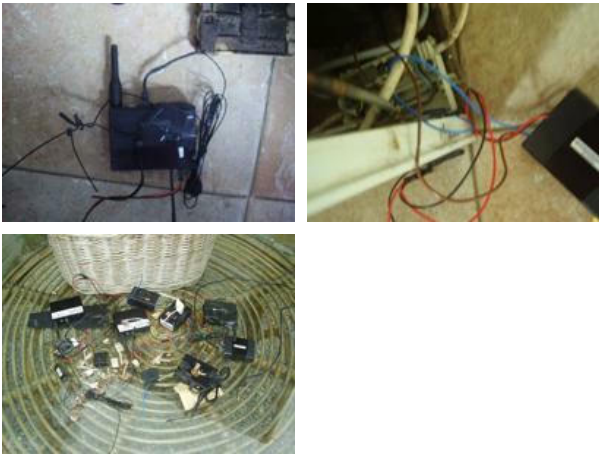
**Four microphones and a camera** were found in a house. A microphone was located **behind the fridge**, another **in the bedroom**, another **in a beam next to the ceiling light**, another **in the house entry**. A small camera **filmed the entry stairs**. All were connected through a transformer to the house electrical network.

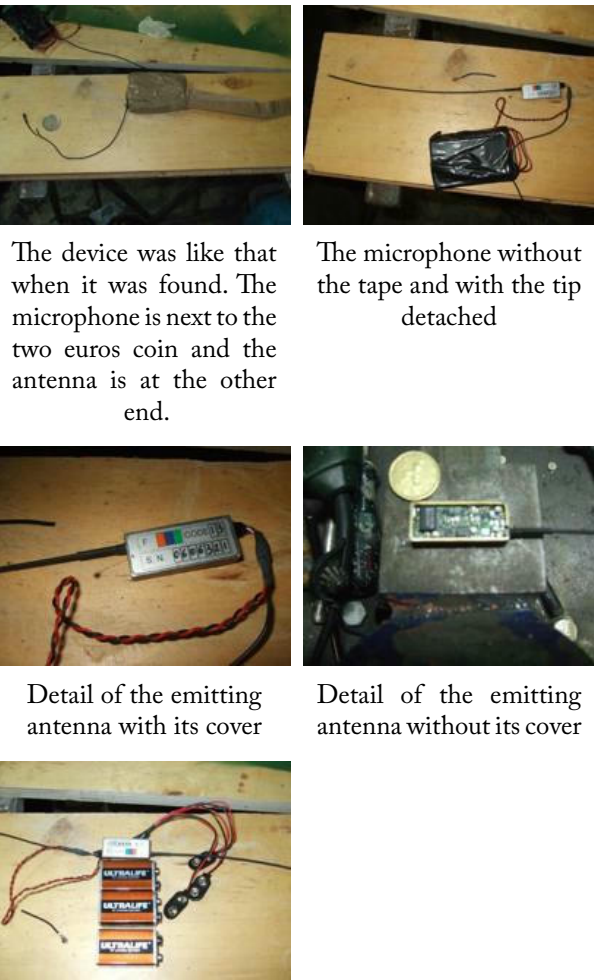
Everything dismantled. The batteries were without power.

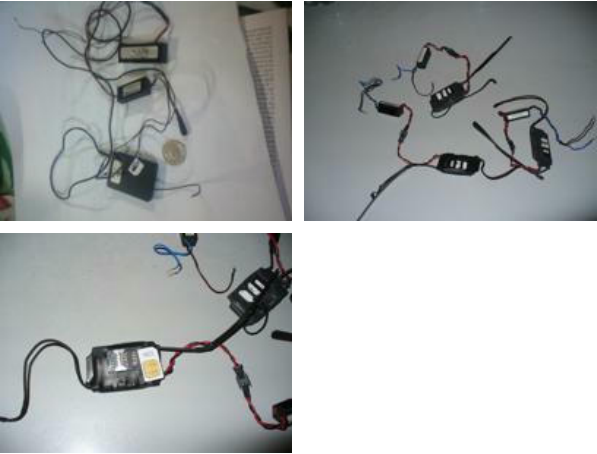
the outlet next to the kitchen table, and the last one in the bedroom, in the outlet closest to the bed (the outlet cover had been pierced to direct the microphone towards the headboard). In the second home, a microphone was located in the bedroom, in the outlet closest to the door leading to the kitchen, so that it covered several rooms. The first home's microphones included a transformer and antennas with a printed circuit board. The second home's microphone included two transformers and an antenna.

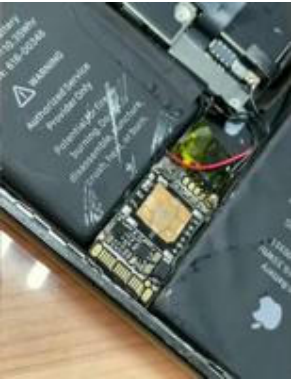
A **surveillance device** was found **inside the smart-phone** of the campaign manager of a Russian anti-corruption activist. It included a SIM card, a microphone, a GPS tracker, and a microcircuit to amplify the radio signal. Some of the phone components were modified to make room for the surveillance device. The device was installed when the owner of the phone was in custody and her phone confiscated. The device was probably installed by the FSB (“Federal security service”).

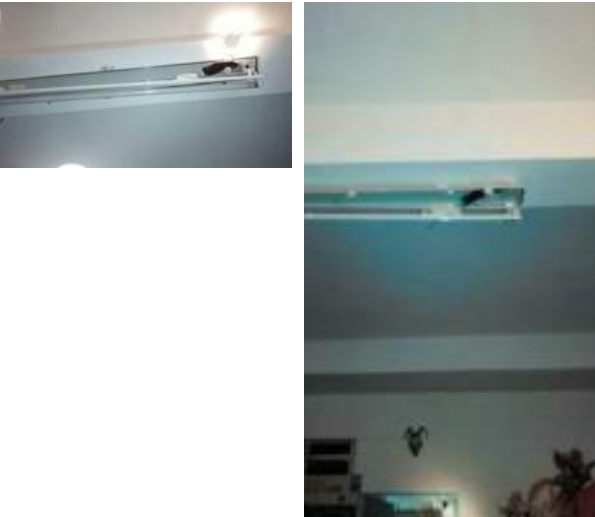
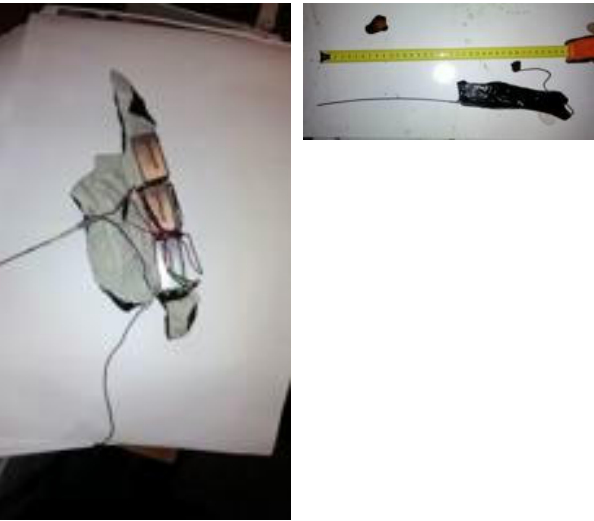
A **microphone** was found in a building. It was located **inside a neon light attached to the ceiling**. It consisted in three 9-volts batteries, joined together with insulating tape, with a microphone and antenna at each end.

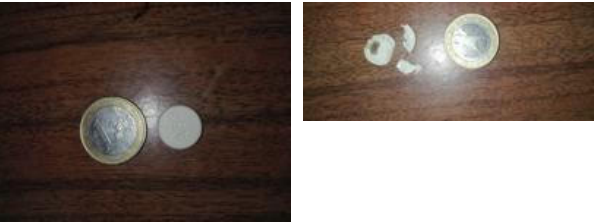
A **surveillance device** was found in a building **inside an outlet not connected to any electrical network**. The acronym “ABG” was visible on one of its edges.

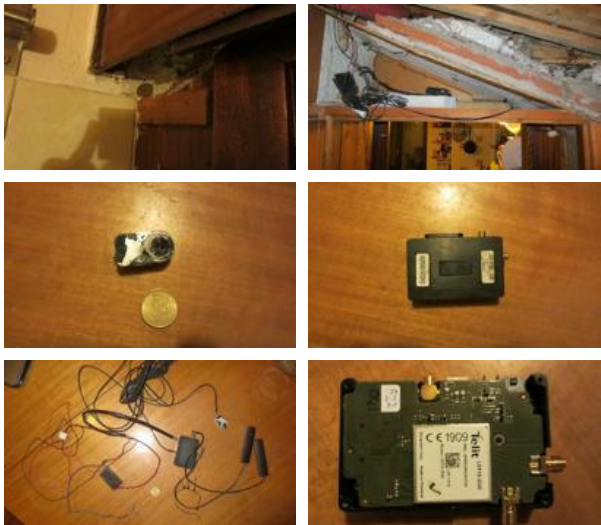
covered up by mortar, revealing only the hole for the camera's lens.

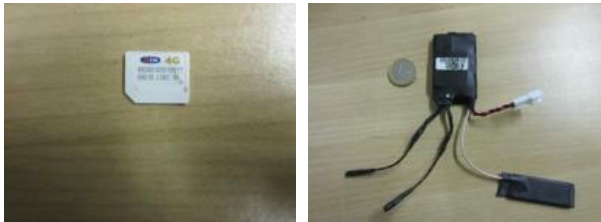
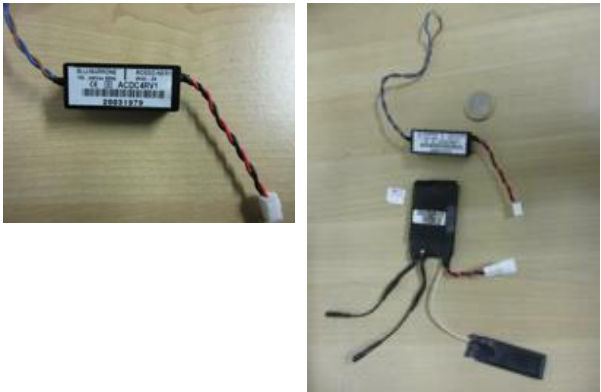
Two microphones were found in a building. They were hidden inside a power outlet and in the junction box next to it.

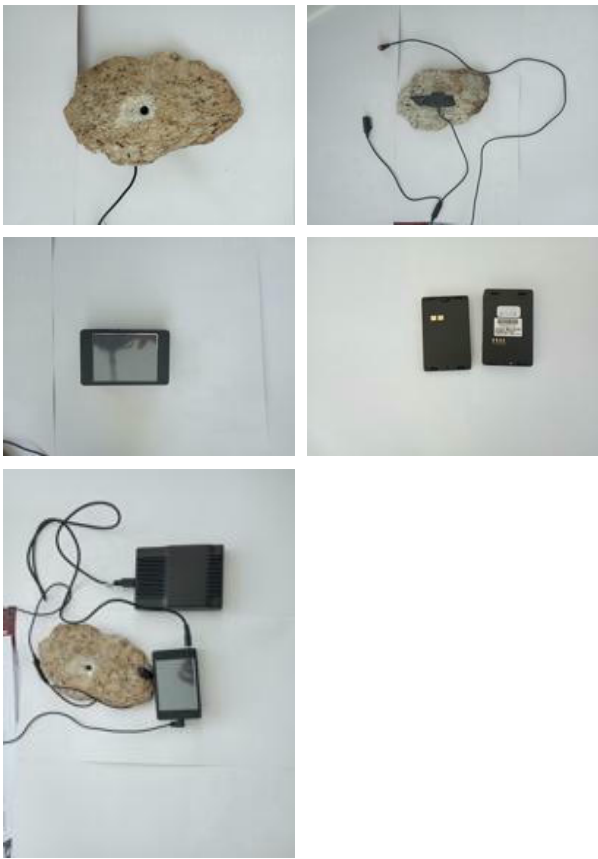
The pictures of the device show that the device included a digital video recorder of model “DK-PV500E”, marketed by the Italian company DSE (Digital Surveillance Equipment). This suggests that the device was supplied by the Italian company DSE.

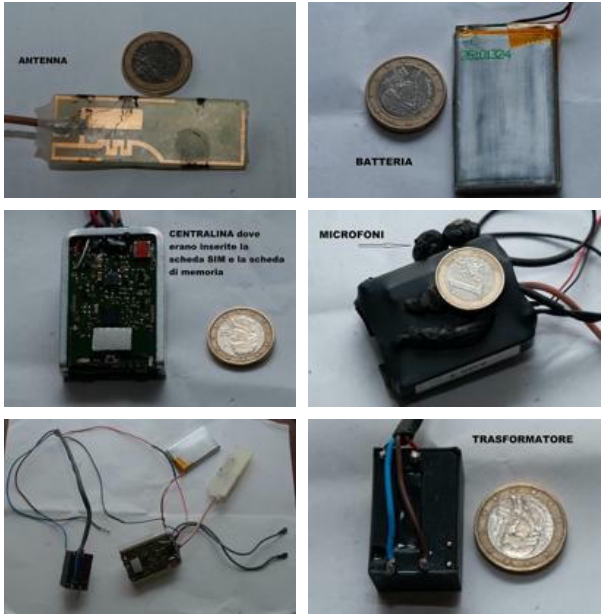
According to the source that reported the discovery of the microphones, they were supplied by the Italian company **Lutech**.

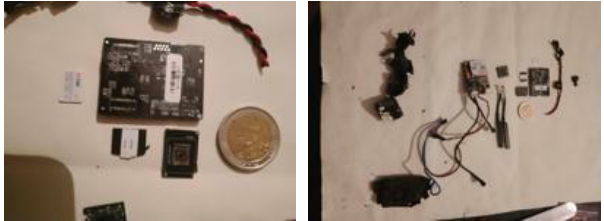
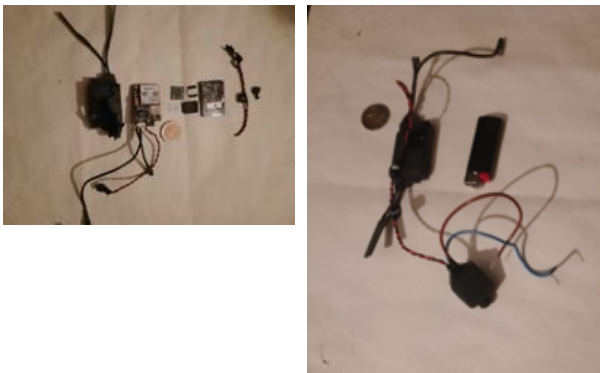
A **microphone** was found in a building. It was located **inside a power outlet**. It was equipped with a microphone, two antennas, a SIM card, a memory card and a battery.

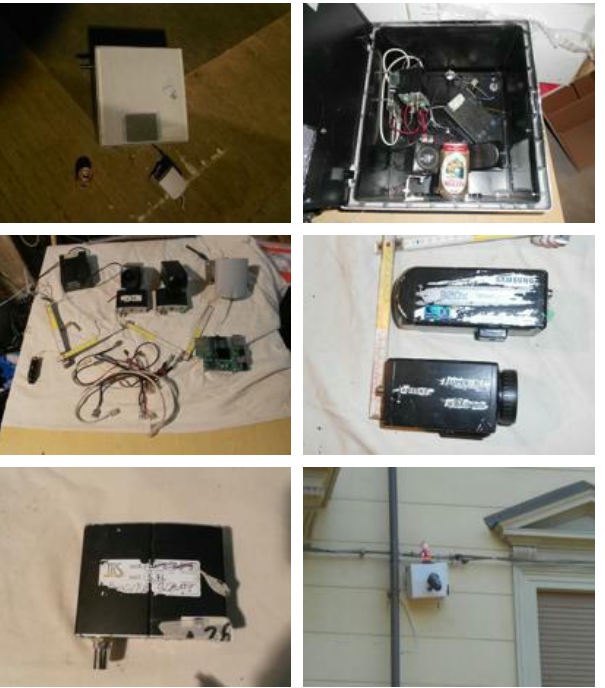
The logo of the Italian company Gruppo TRS, which was bought in 2012 by the Italian company Atet, is visible on the pictures of the cameras. This suggests that the cameras were supplied by the Italian company **Atet**.

The box were the cameras were found
