Ears and Eyes

With Pictures

Part 2/2
Italy-Unknown country

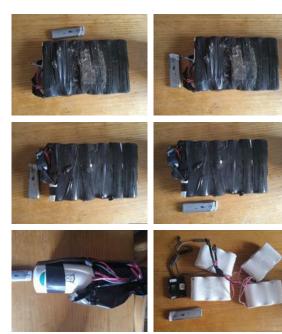
A microphone was found in a house.

A microphone was found in a house. The device was connected to the fridge electrical outlet. It included a microphone, two antennas and a SIM card.
