Ears and Eyes

Ears and Eyes, With Pictures

No Trace Project

The *Ears and Eyes* project is a searchable database of cases of physical surveillance devices (microphones, cameras, location trackers...) hidden by law enforcement and intelligence agencies to surveil people or groups engaged in subversive activities. Our goal is to help the potential targets of such surveillance practices to better understand and resist them.

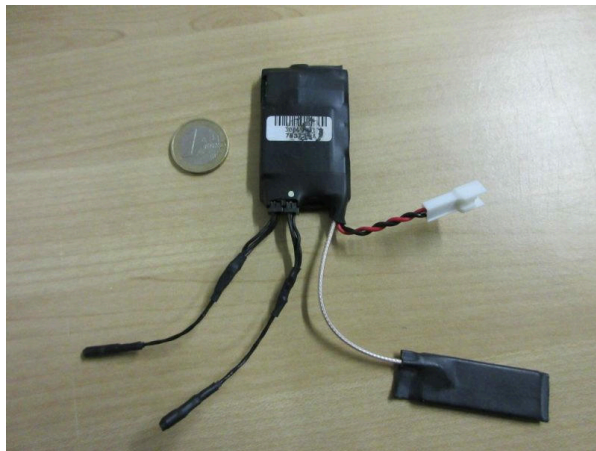
Microphones found inside a power outlet in a building in Bologna, Italy, in January 2018.¹

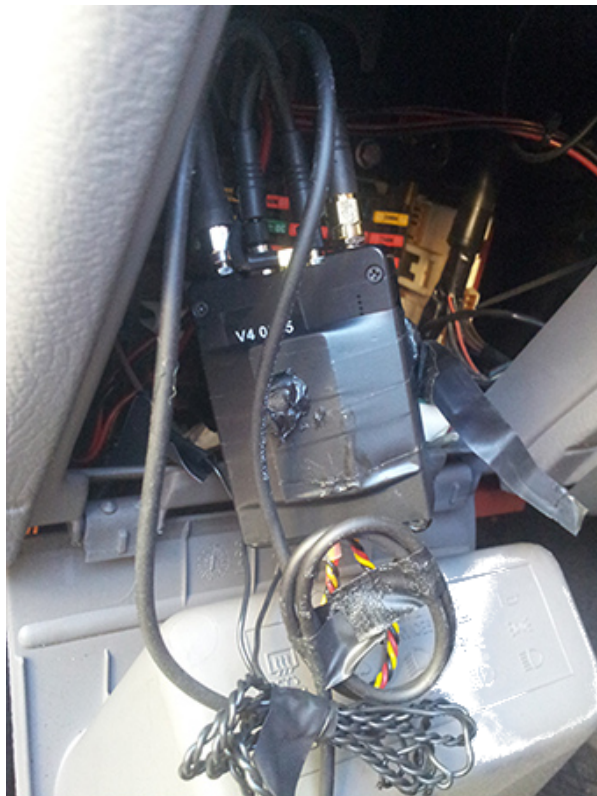
Microphones and a GPS tracker found in the fuse box of a car in Lecce, Italy, in December 2017.²

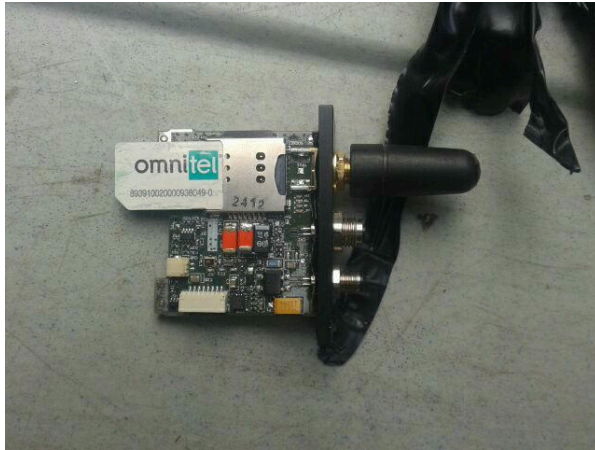
A device equipped with a SIM card found in a vehicle in Italy, in August 2019.⁵

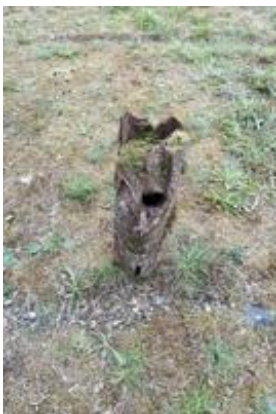
Four cameras were found outside a large area where people lived. They were hidden **near an access gate to the area, camouflaged in a fake tree log and fake stones**. They filmed continuously and were connected, via buried cables, to large batteries and concealed modems. The mention “Allwan” was visible on a label on a camera. The cameras were found on August 31, and appeared to have been installed right before a event organized in the area on August 29 and 30.

1: first camera group; 2: portal; 3: second camera group.

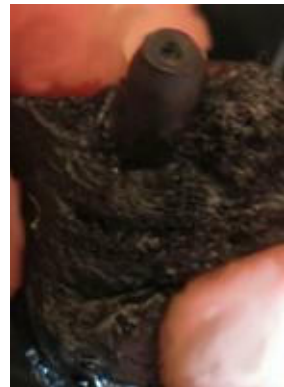
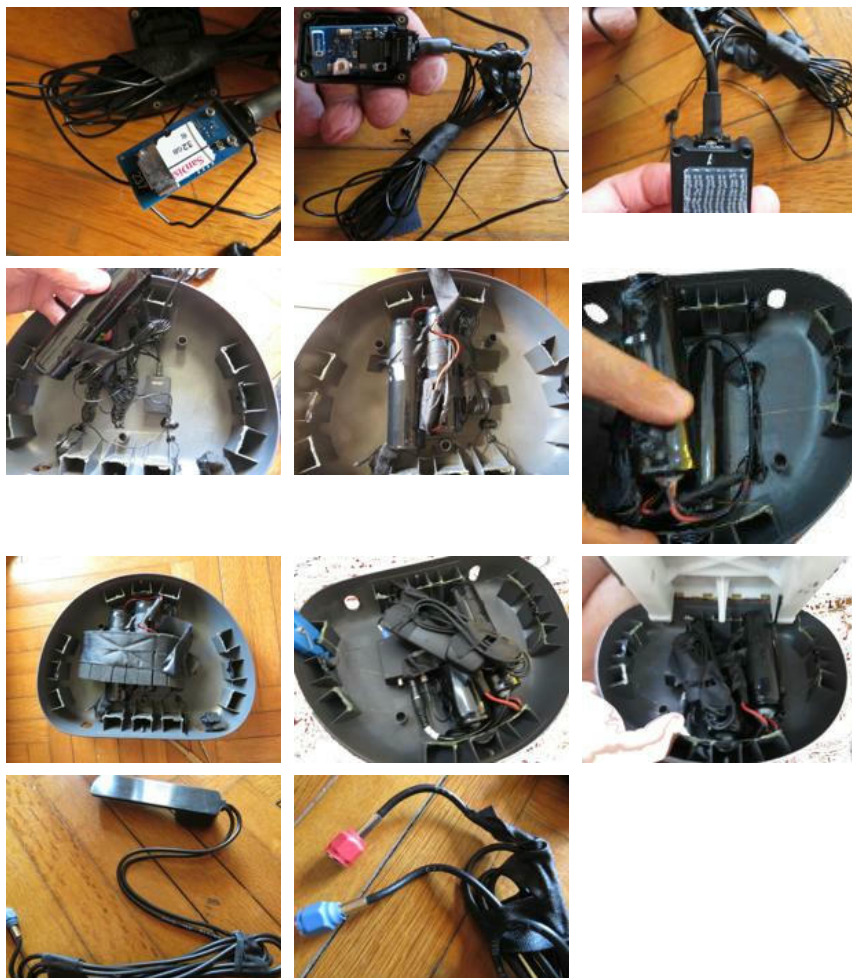
A **GPS tracker and a microphone** were found in a car. The two devices were installed separately, **each in one of the front seat headrests**. The headrests were opened and glued back together after the devices were installed. Each device was equipped with two batteries. The first device, which was apparently the control unit, was equipped with a GSM module to send GPS data and recorded audio files via the mobile phone network. On the control unit were a GPS/GSM antenna, the connection to the batteries and a microphone. Inside the device, a SIM card was found. The second device seemed to be the actual audio monitoring device. It also had a battery connection, a smaller antenna and two microphones, which had been glued into the holes for the seat support, with anti-vibration padding. This device was equipped with an SD card, but there were no more audio files stored in it. The SD card was apparently used as a storage medium for the operating system data and for temporary storage of the

2: the two batteries of the listening device; 4: microphones connected to the listening device; 6: dismantled listening device; 7: SD card.

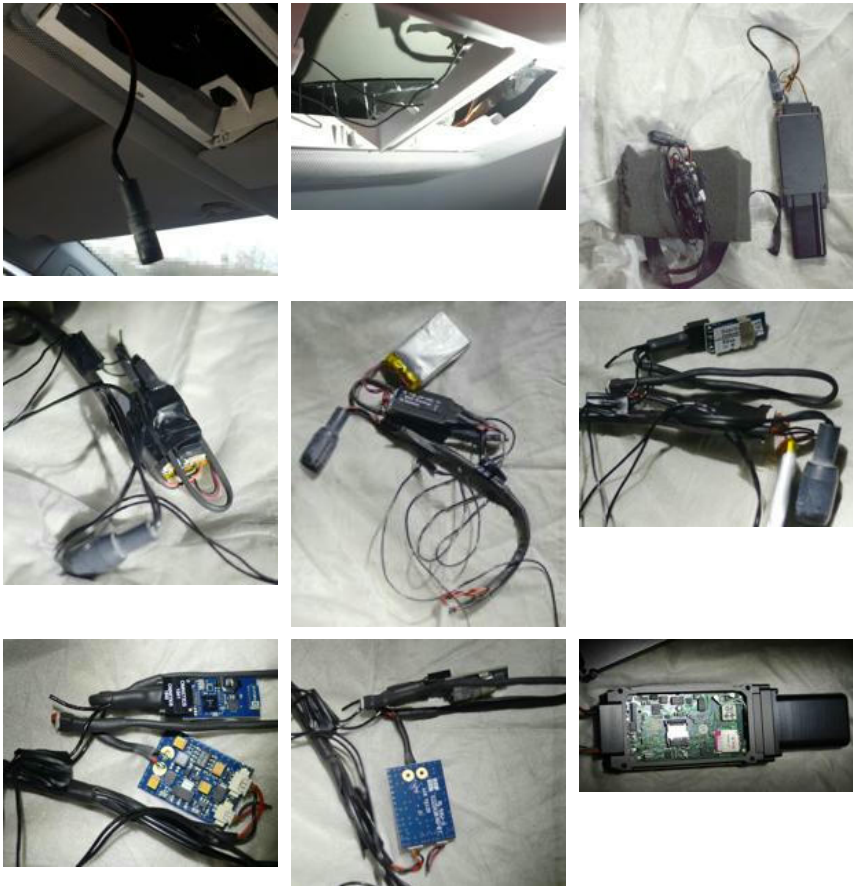
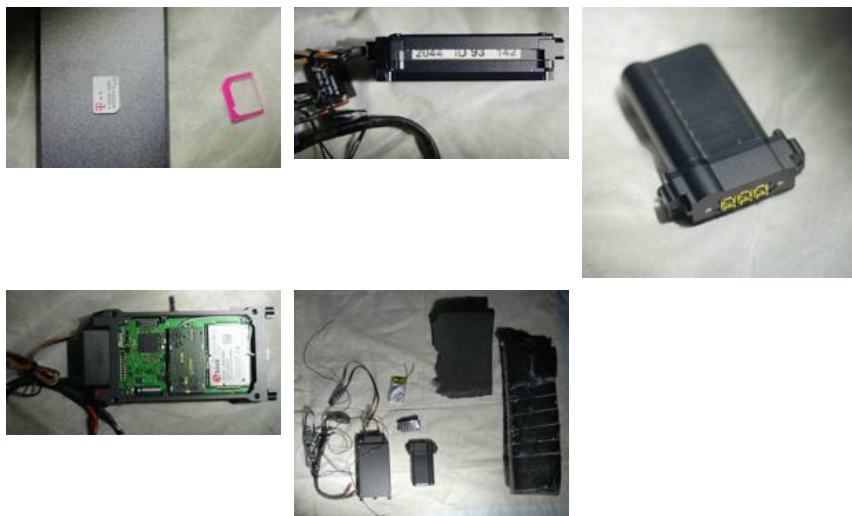
A **GPS tracker** and an **audio recording device** were found in a car. They were located **behind a panel of the front ceiling light**. They were connected by a power cable and drew their power from the supply line to the rear ceiling light. The GPS tracker contained, among other things,

a GPS receiver “u-blox MAX-M8”, a card slot with a 16 GB microSD card, a cellular chip “u-blox LISA-U230” along with a SIM card, as well as a removable three-pin antenna module. The audio recording device contained a voltage converter, a 3.7 V, 550 mAh lithium-ion battery, and a small circuit board which included a 32 GB microSD card and the “NN01-104” antenna from the company Ignion (formerly “Fractus”). The audio recording device tapped into the microphone of the hands-free system, which was located behind a cover above the rearview mirror.

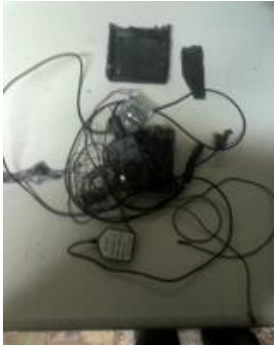
A **GPS tracker and microphones** were found in a car. The device was located **in a plastic container (badly) stuck under the roof**. It contained two boxes, both of which included a SIM card. From there wires went out, through a hole, up to under the back seats. There were two microphones along the seat belt canal: the first at the driver's height, the second at the height of the levers used to adjust the seat, next to the back seats. The antenna was behind the back seat. Finally, still coming from these two boxes, a wire went through the car doors to reach the car fuse box.

Overall view of the device

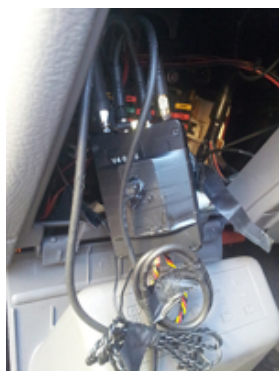
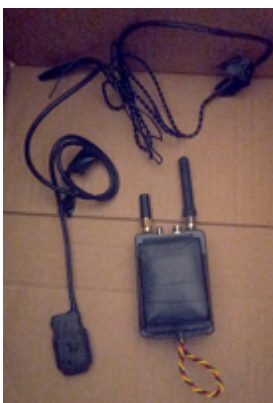
Microphones and a GPS tracker were found in a car. They were located **in the fuse box**. The car had been having electrical problems (the battery had discharged twice in a month, sign of an abnormal electricity consumption), presumably because of the devices.

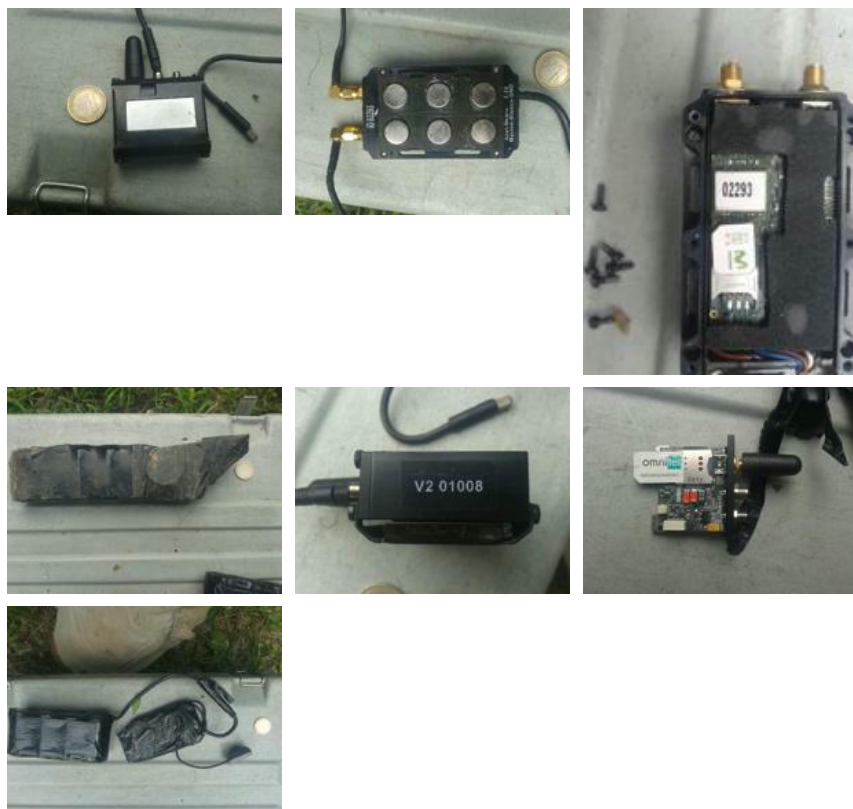
A microphone and two GPS trackers were found in a vehicle. A first tracker was **attached with a magnet to the rear bumper, on the right side**. The other tracker, along with the microphone, was located **in the air vents located between the windscreen flap and the windscreen**. The first tracker included a SIM card and an accumulator made of five 3.6 V lithium batteries connected in a series. The other tracker was equipped with a SIM card.

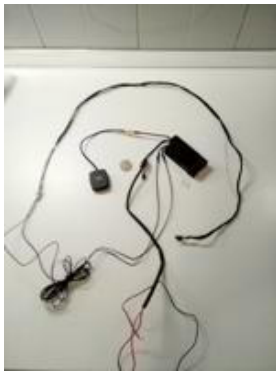
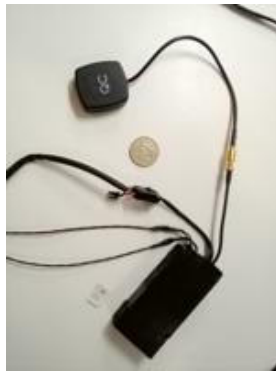
A **tracking device and two microphones** were found in a car. The tracking device was **connected to the power supply of the control unit underneath the steering wheel on the left side**. It was **attached with a magnet, tape, and insulating fabric**. The microphones were located **at the end of a long cable running from the inside of the internal side pillar linings of the windscreen to the underside of the roof of the car**. The tracking device used the GLONASS positioning system, and consisted of an antenna connected to a multi-frequency receiver box containing a micro SIM card.

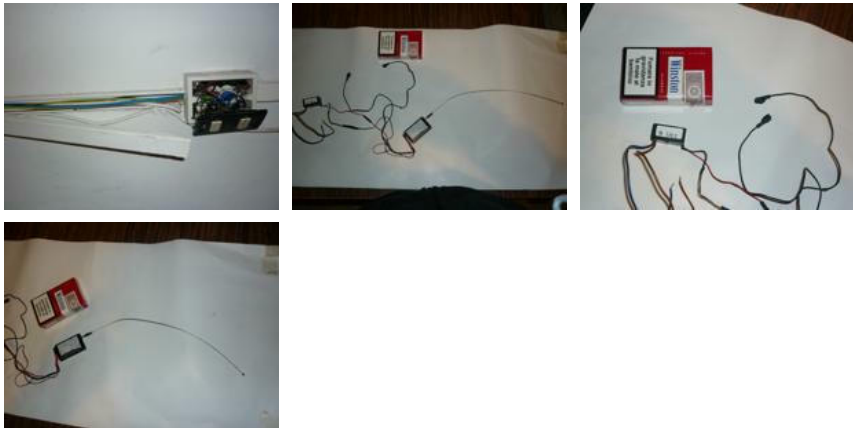
A **microphone** was found in a building. It was located **inside an electrical outlet**. It was a transmitter-receiver.

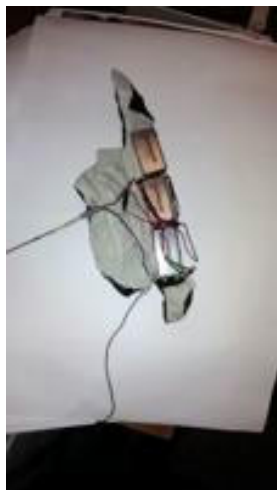
A **microphone** was found in a building. It was located **inside a neon light attached to the ceiling**. It consisted in three 9-volts batteries, joined together with insulating tape, with a microphone and antenna at each end.

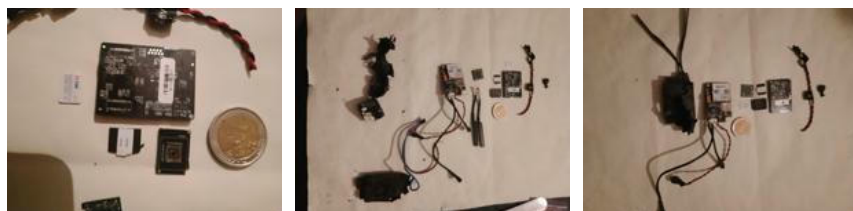
A **microphone** was found in a building. It was located **inside a power outlet**. It was equipped with a microphone, two antennas, a SIM card, a memory card and a battery.

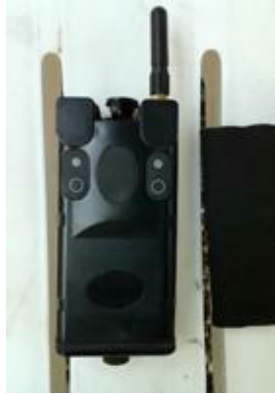
First tracker, out of its sleeve
