Ears and Eyes

With Pictures

Part 1/2

Belgium–Ireland

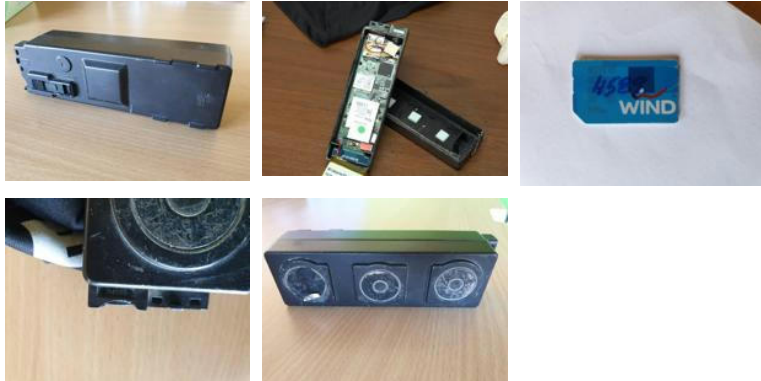
Unknown location, August 2019

A **GPS tracker** was found on a car. It was **attached with a strong magnet**. It was equipped with a SIM card and a battery.

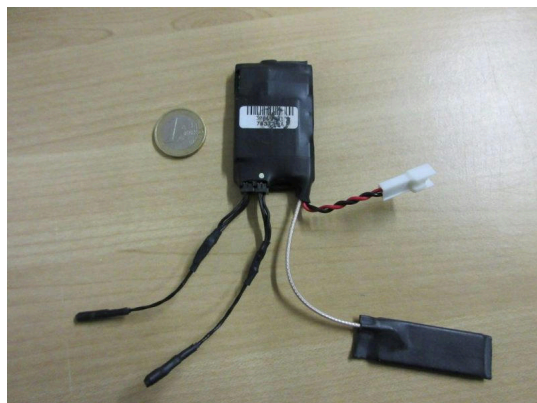
Microphones found inside a power outlet in a building in Bologna, Italy, in January 2018¹.

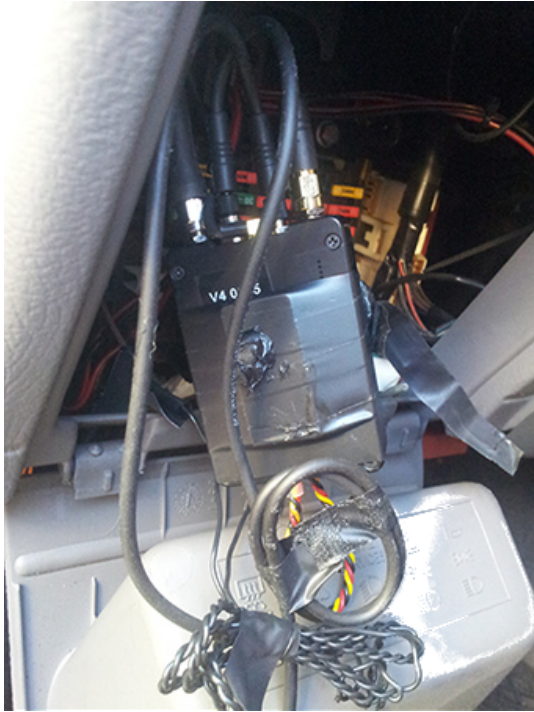
Microphones and a GPS tracker found in the fuse box of a car in Lecce, Italy, in December 2017².

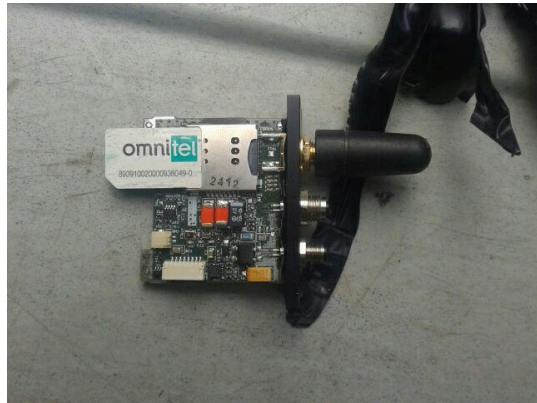
A device equipped with a SIM card found in a vehicle in Italy, in August 2019⁵.

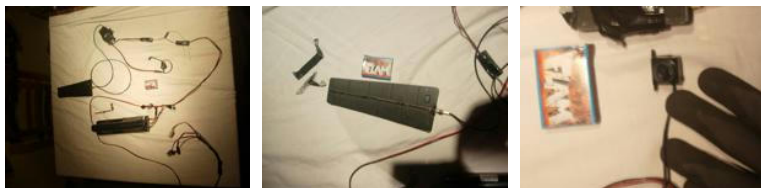
A **camera** was found at two anarchists' houses. The device was placed **in the kitchen, behind a small air vent**. It consisted in a camera, linked to a rather large battery made of 3 tubes of 4 batteries of 14.4 volts. The battery was behind the sink. Between the battery and the rest of the device was what seemed to be a switch, that could be manipulated remotely. The camera was connected to a small black box that served as an encoder. This encoder, type "Micro View Lock" (Ovations Systems), was in turn connected to what may have been an antenna to transmit images on 1.4 GHz. There was no SIM card. The camera was pointed towards the kitchen table. It was not known if it also contained a microphone. The camera was secured with magnetic elements. On almost all elements "CS" stickers were affixed. "CS" indeed matched the code of the Logistics Department of the Federal Police.

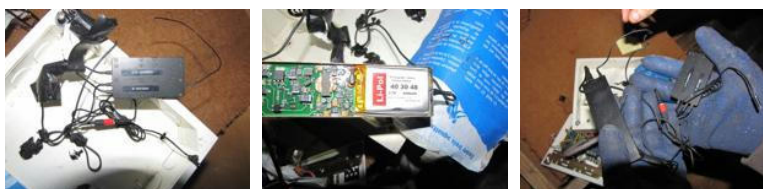
A **microphone** was found in the squat Awhanee. It was located **in a multi-socket adapter**. The device contains a printed circuit board and a battery. It seems that the device was installed during a house search by cops earlier in the month.

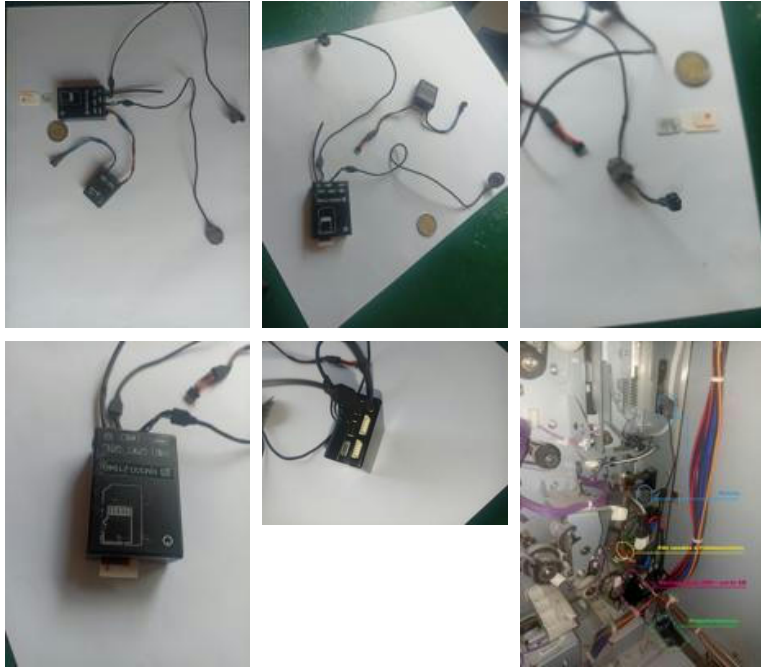
Blue: microphones;
 Yellow: wires soldered to the power supply;
 Pink: small box with SIM card + SD card;
 Green: transformer

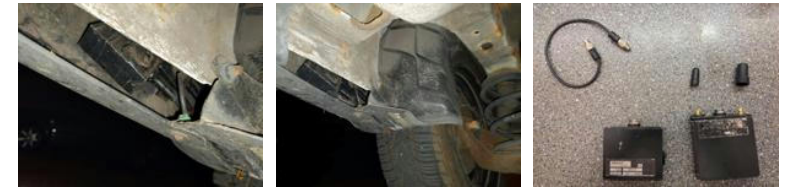
Two GPS trackers were found under a vehicle (the second one was found a few days after the first one was found and removed). They were **attached with strong magnets in a hollow space between the plastic covering of the bumper and the body, precisely behind the left rear wheel**. Each tracker consisted of two metal cases connected by a cable. The first one contained a battery pack, and the second one the tracker itself, including a smaller battery, two antennas, and a SIM card.

The pictures of the device show that a tracker of model NavKos T, marketed by the german company DESAG Telematic, was part of the device. This suggests that the device was supplied by the german company **DESAG Telematic**.

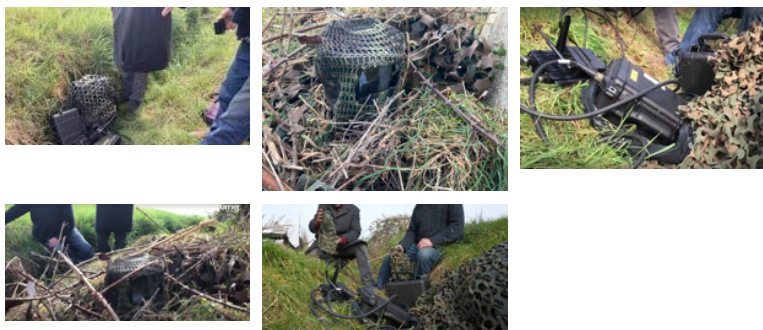
A **surveillance camera** was found **at the entrance of the village, pointed towards the home of an environmental activist**. The camera, **barely emerging from the ground, was covered with brambles and grass**. It was connected to a Pepwave router and to two cases containing high-tech lithium batteries labeled Accuwatt, hidden in a ditch, under a tarp and a camouflage net.

High-technology batteries found alongside the cameras were marketed by the company **Accuwatt**, specialized in batteries for armies and law enforcement agencies.
