Ears and Eyes

With Pictures

Ears and Eyes is a searchable database of cases of physical surveillance devices (microphones, cameras, location trackers...) hidden by law enforcement and intelligence agencies to surveil people or groups engaged in subversive activities.

Belgium–Ireland

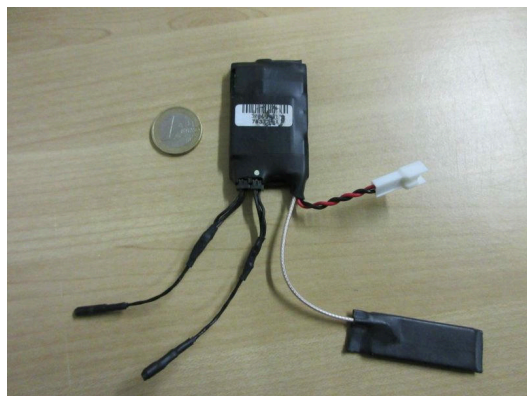
Microphones found inside a power outlet in a building in Bologna, Italy, in January 2018.¹

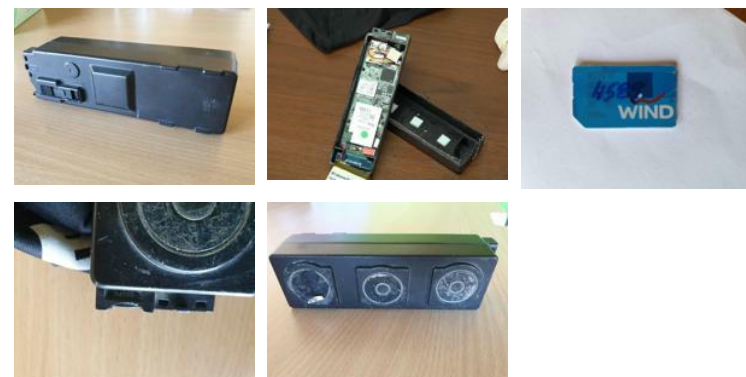
A **GPS tracker** was found on a car. It was **attached with a strong magnet**. It was equipped with a SIM card and a battery.

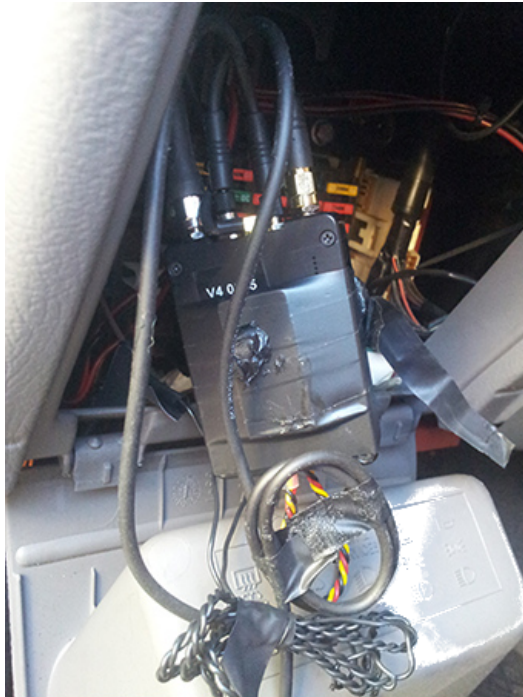
Microphones and a GPS tracker found in the fuse box of a car in Lecce, Italy, in December 2017.²

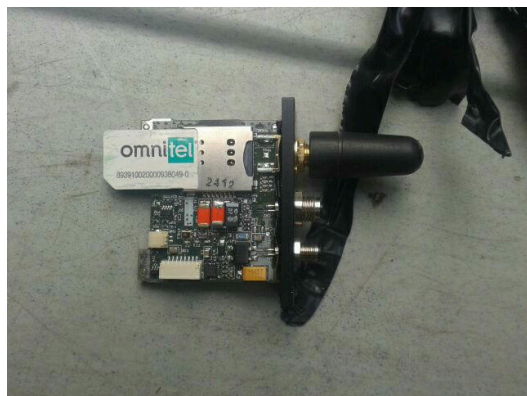
A device equipped with a SIM card found in a vehicle in Italy, in August 2019.⁵

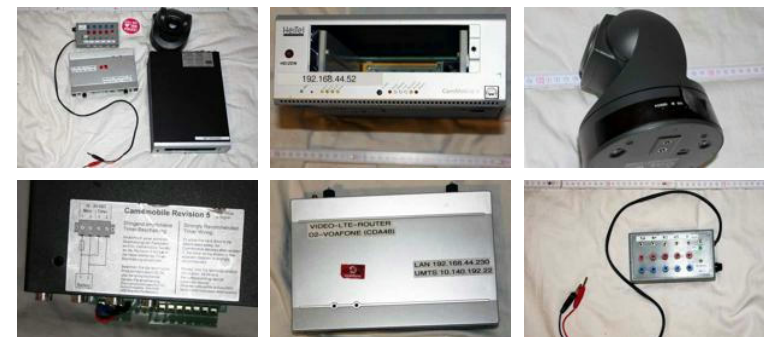
A **video surveillance device** was found. It was located **on the second floor of a vacant house**. It contained a swiveling camera which was connected to a hard disk and could be controlled via an LTE mobile phone connection, and a battery to power the device. Through a window, the camera had a view of the sidewalk, several building entrances and several apartment windows. The device could not be seen from the outside as its luminous diodes had been masked off.

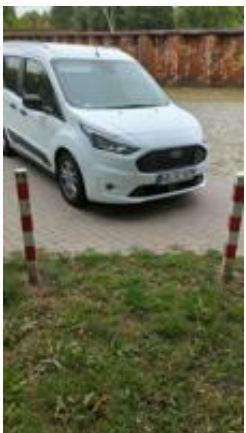
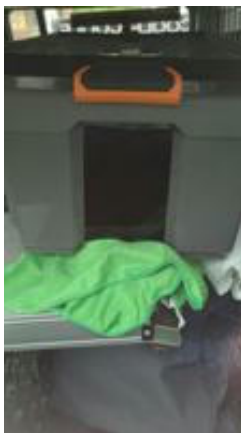
A **camera** was found in a car parked near the venue of an event. It was located **in a box, behind a tinted panel**. It had a good view on the venue's entrance. A flashlight pointed at the box revealed the camera, despite the tinted panel.

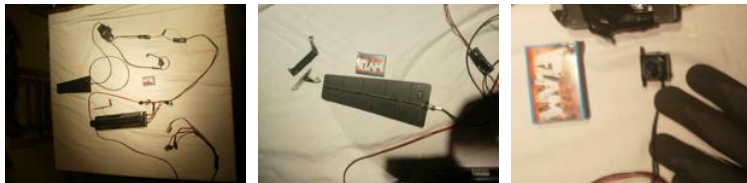
A **camera** was found in an apartment. The device was located **in the kitchen, behind a small air vent**. It consisted in a camera connected to a large battery made of 3 tubes of 4 batteries of 14.4 V. The battery was behind the sink. Between the battery and the rest of the device was what seemed to be a switch that could be manipulated remotely. The camera was connected to a small black box that served as an encoder. This encoder, of model “Micro View Lock”(marketed by Ovations Systems), was in turn connected to what may have been an antenna to transmit images on a 1.4 GHz frequency. There was no SIM card. The camera, secured with magnets, was pointed towards the kitchen table.

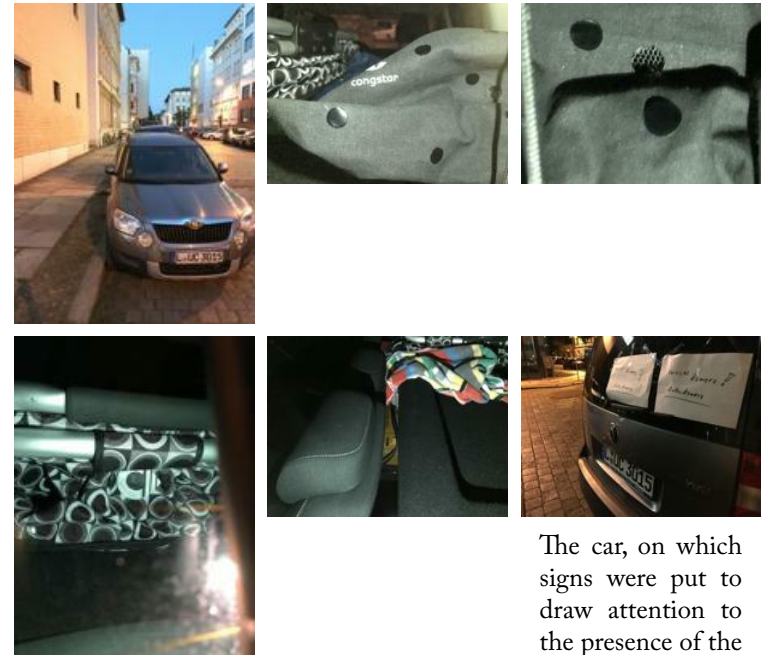
The car, on which signs were put to draw attention to the presence of the cameras (1)

Two cameras were found in a car parked on a street. They were located **on the package shelf, in a basket and a bag respectively**. A set of cables, hidden under towels, led to the trunk of the vehicle. The camera lenses were aimed at a building entrance and a sidewalk.

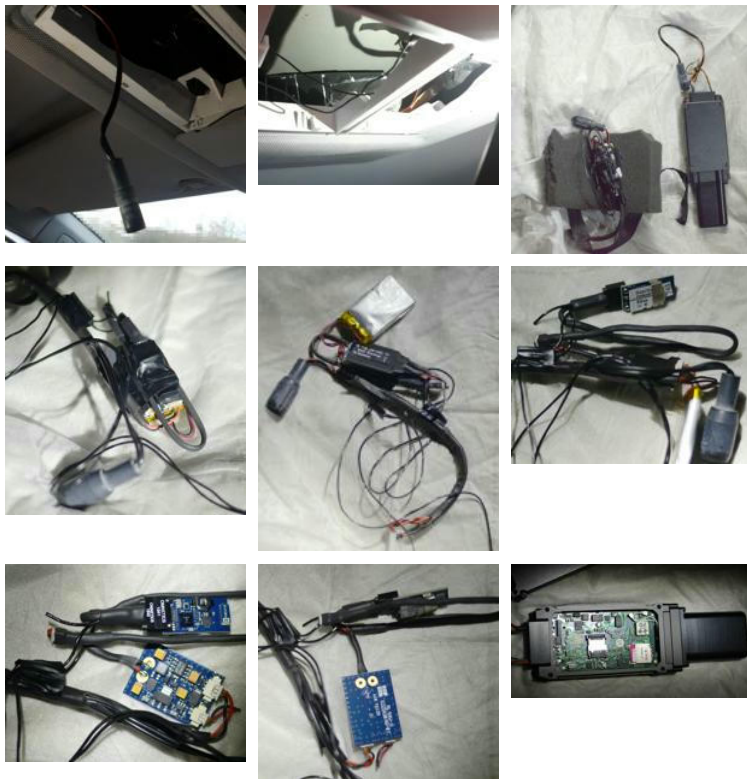
MAX-M8”, a card slot with a 16 GB microSD card, a cellular chip “u-blox LISA-U230” along with a SIM card, as well as a removable three-pin antenna module. The audio recording device contained a voltage converter, a 3.7 V, 550 mAh lithium-ion battery, and a small circuit board which included a 32 GB microSD card and the “NN01-104” antenna from the company Ignion (formerly “Fractus”). The audio recording device tapped into the microphone of the hands-free system, which was located behind a cover above the rearview mirror.

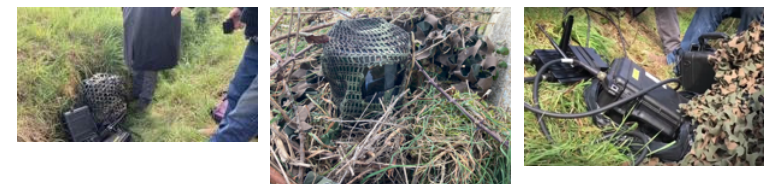
A **camera** was found **outside, pointed towards a house**. It was **barely emerging from the ground and was covered with brambles and grass**. It was connected to a “Pepwave” router and to two cases containing lithium batteries labeled “Accuwatt”, hidden in a ditch, under a tarp and a camouflage net.

The batteries were marketed by the company **Accuwatt**, specialized in batteries for law enforcement and the military.

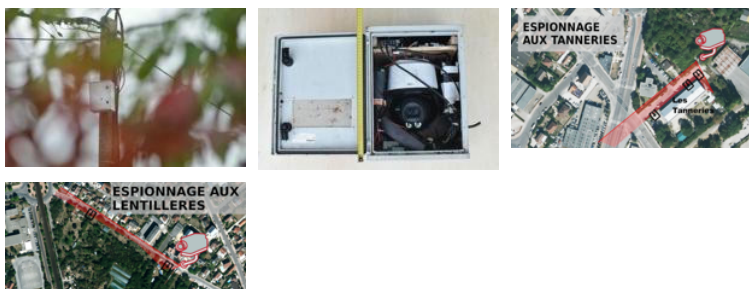
Two cameras were found in the streets. Each was **in a box attached to an electric pole**. They were able to film the entrances and surroundings of the buildings under surveillance. They were present—possibly on and off—since 2019. After the discovery of the first camera, the second one was removed, presumably by the State intelligence services.
