Ears and Eyes

With Pictures

Ears and Eyes is a searchable database of cases of physical surveillance devices (microphones, cameras, location trackers...) hidden by law enforcement and intelligence agencies to surveil people or groups engaged in subversive activities.

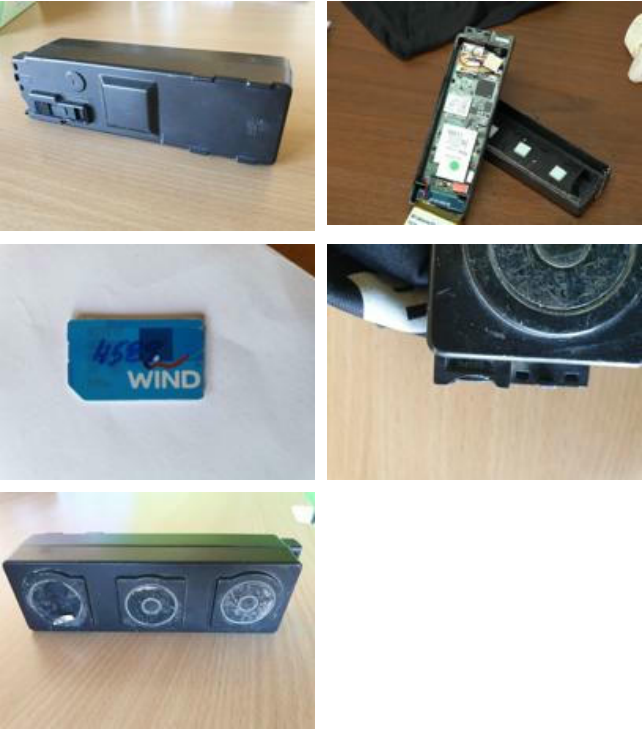
A **GPS tracker** was found on a car. It was **attached with a strong magnet**. It was equipped with a SIM card and a battery.

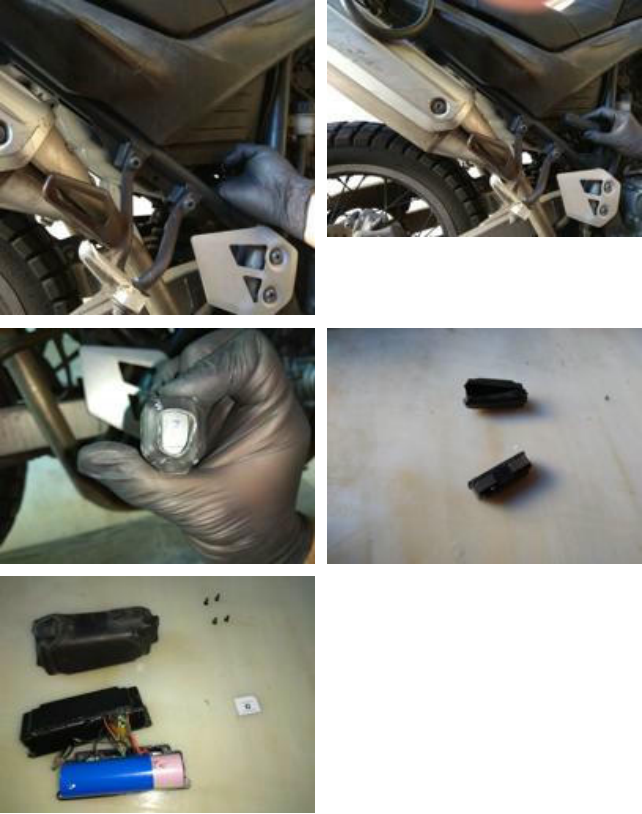
A **GPS tracker** was found on a motorbike. It was **attached with a strong magnet**. It was equipped with a SIM card and a battery.

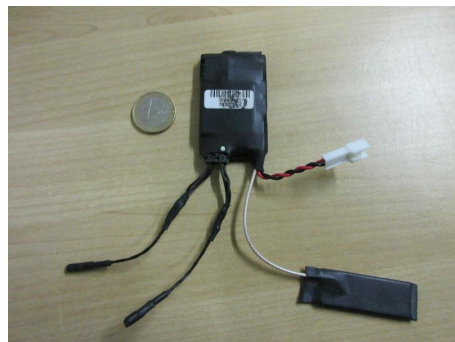
Microphones found inside a power outlet in a building in Bologna, Italy, in January 2018.¹

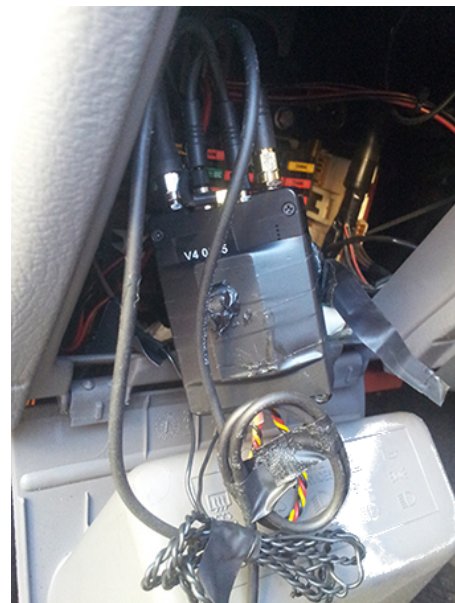
Microphones and a GPS tracker found in the fuse box of a car in Lecce, Italy, in December 2017.²

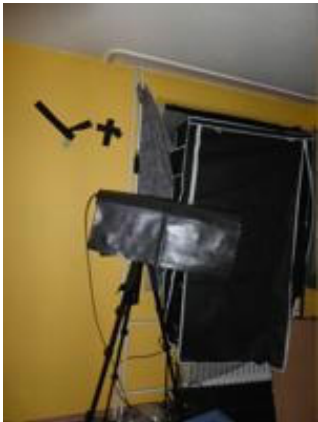
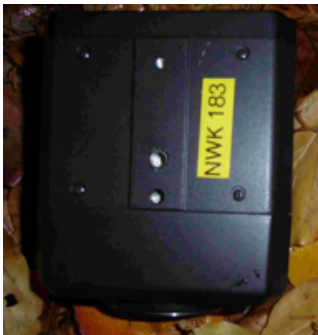
Sony camera (1)

Three surveillance cameras were found in a building, pointed towards the entrance of a wagenplatz (a leftist political community where people live in trailers). They were located in a locked room, on the sixth floor of a building close to the wagenplatz—the building in question was vacant except for its first floor. One of the cameras was a “Sony ISO 409600 Extreme Sensitivity 4K” with a high-grade “Sony SEL 600mm F4 GM OSS E-mount” telephoto lens. The two other cameras were “Panasonic WV-S6131” IP cameras.

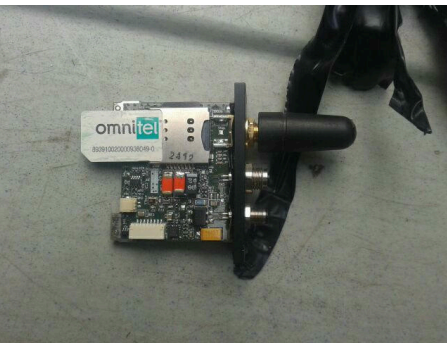
A device equipped with a SIM card found in a vehicle in Italy, in August 2019.⁵

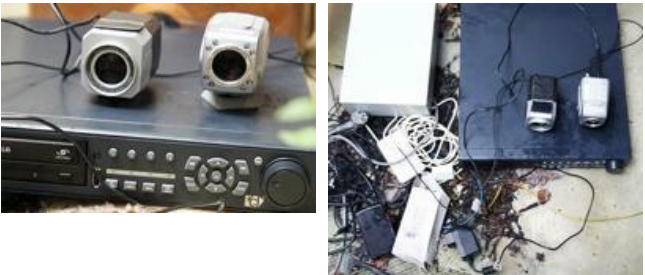
A video surveillance device was found. It was located on the second floor of a vacant house. It contained cameras mounted on tripods, which filmed the public space through windows.

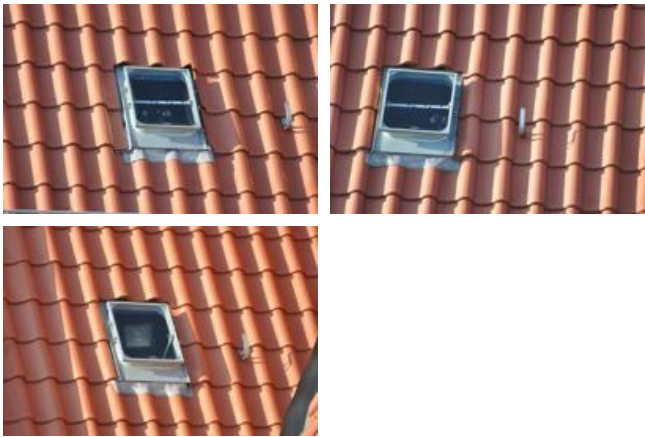
Several cameras were found in the attic of a public school located in front of a recently evicted squat, overlooking the squat through the skylights.

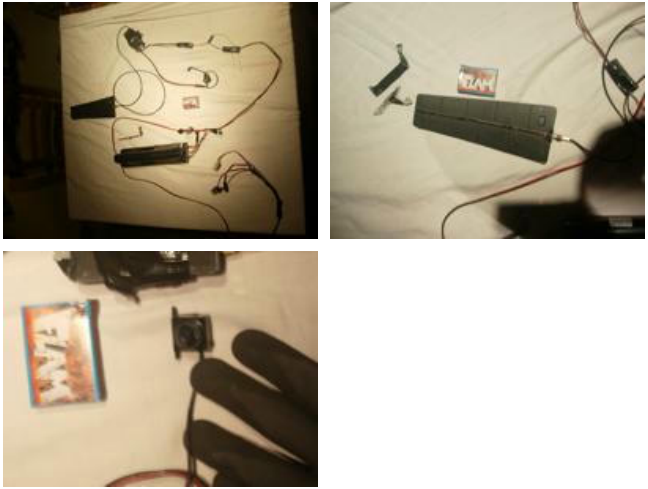
A **camera** was found in an apartment. The device was located **in the kitchen, behind a small air vent**. It consisted in a camera connected to a large battery made of 3 tubes of 4 batteries of 14.4 V. The battery was behind the sink. Between the battery and the rest of the device was what seemed to be a switch that could be manipulated remotely. The camera was connected to a small black box that served as an encoder. This encoder, of model “Micro View Lock” (marketed by Oventions Systems), was in turn connected to what may have been an antenna to transmit images on a 1.4 GHz frequency. There was no SIM card. The camera, secured with magnets, was pointed towards the kitchen table.

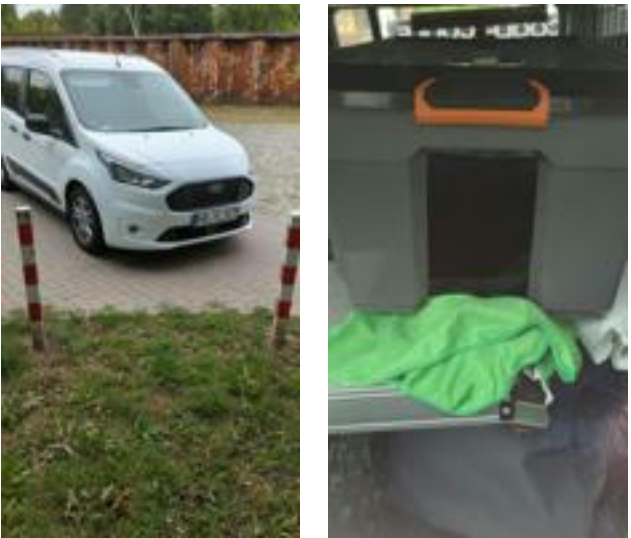
A **camera** was found in a car parked near the venue of an event. It was located **in a box, behind a tinted panel**. It had a good view on the venue's entrance. A flashlight pointed at the box revealed the camera, despite the tinted panel.

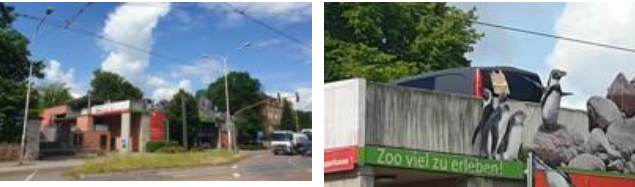
A **camera** was found **in a car parked on the parking lot of a zoo, near a social center**. It was mounted on a vertical cylinder and attached to the interior surface of the car. It was overlooking the social center. The car was seen parked there on several occasions in April and May 2025.

The car parked on the parking lot of the zoo, with a piece of cardboard attached to block the camera lens (1)

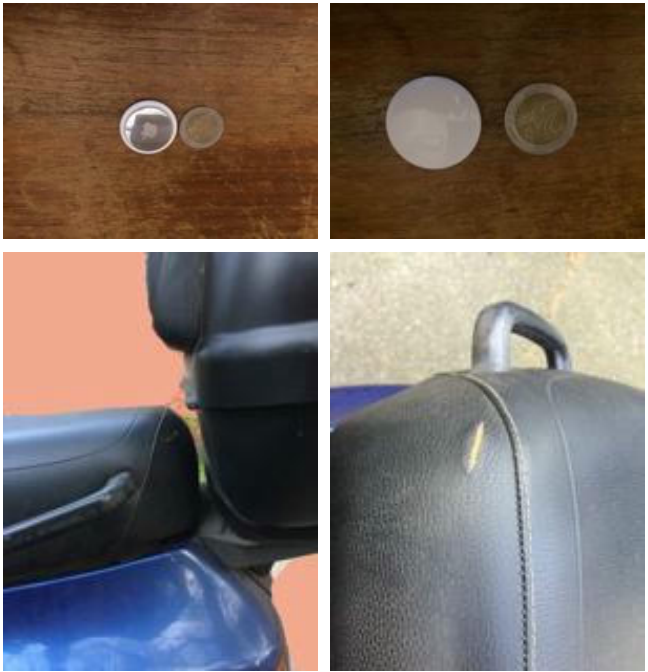
An **AirTag**—a tracking device marketed by Apple—was found on a scooter. It was hidden **inside the scooter seat cushion**, in which it had been inserted through a slit apparently made with some sort of blade. It had an approximate diameter of 3 centimeters and a height of less than 1 centimeter.

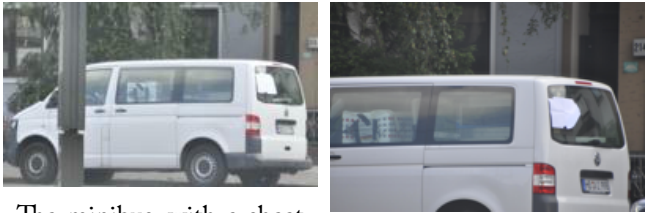
A **camera** was found in a minibus parked near the venue of an event. It was located **in the back of the vehicle, on a shelf, in a plastic box, one side of which had been replaced by tinted glass**. The minibus was disguised as a craftsman's vehicle, with work equipment clearly visible, tools and empty coffee cups on the passenger seat.

The minibus, with a sheet attached to block the camera lens (1)

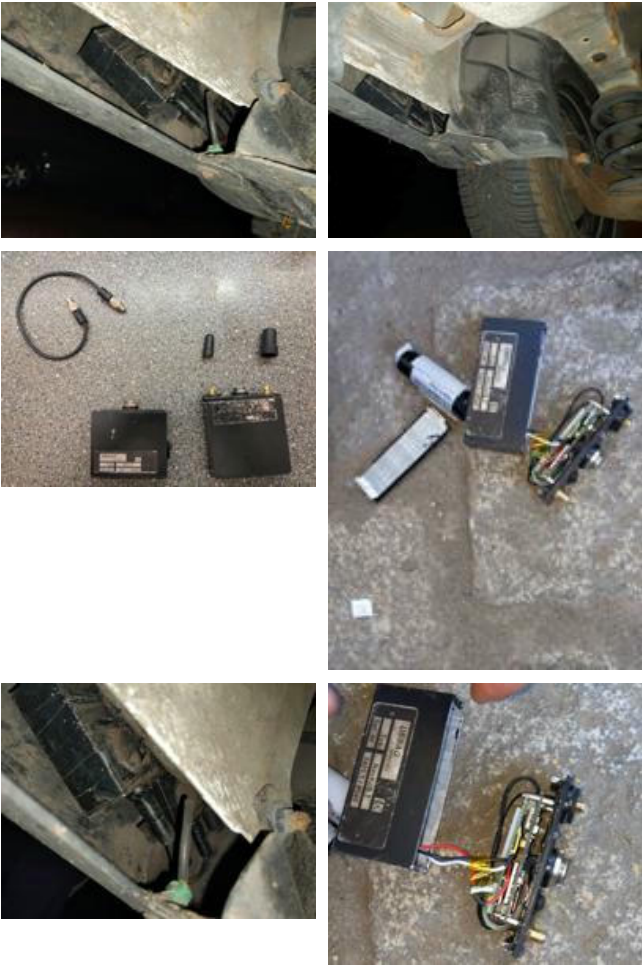
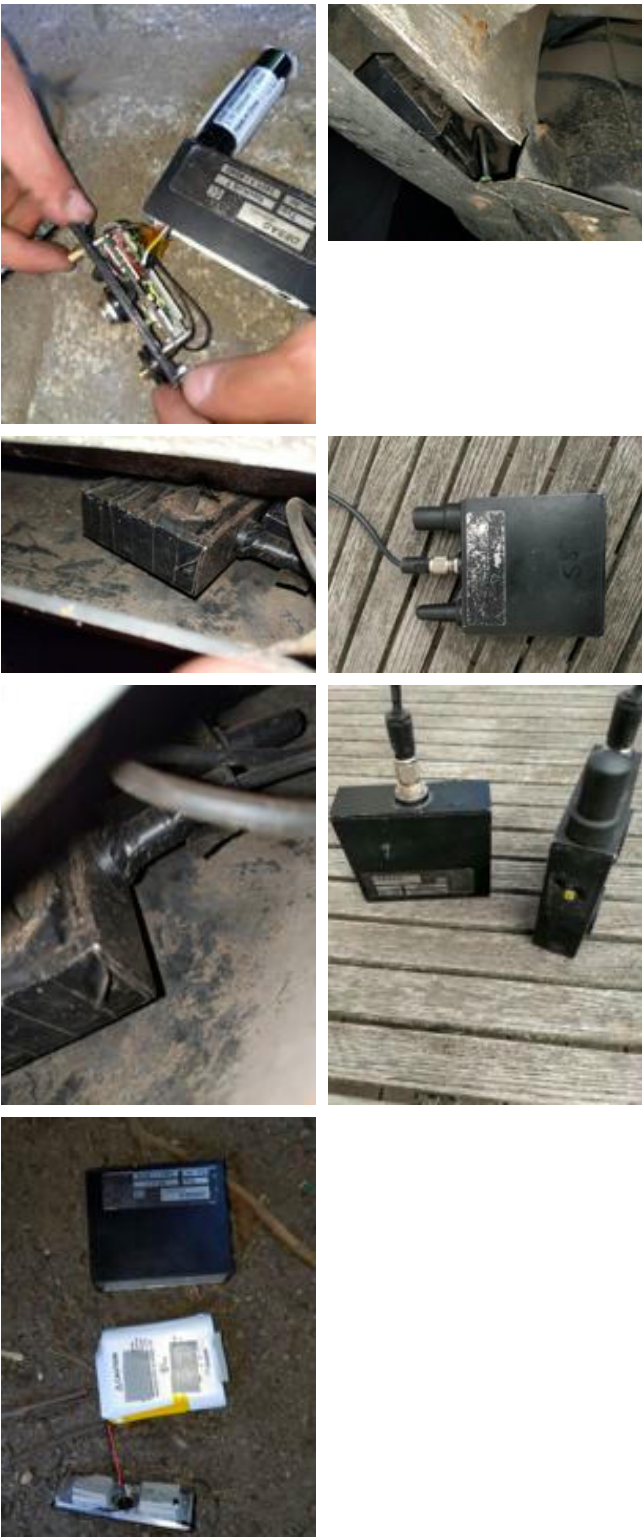
found and removed. They were **attached with strong magnets in a hollow space between the bumper's plastic covering and the vehicle body, precisely behind the left rear wheel**. Each tracker consisted of two metal cases connected by a cable. The first one contained a battery pack and the second one the tracker itself, including a smaller battery, two antennas, and a SIM card.

The pictures of the device show it included a tracker of model “NavKos T” marketed by the German company DESAG Telematic. This suggests that the device was supplied by the German company **DESAG Telematic**.

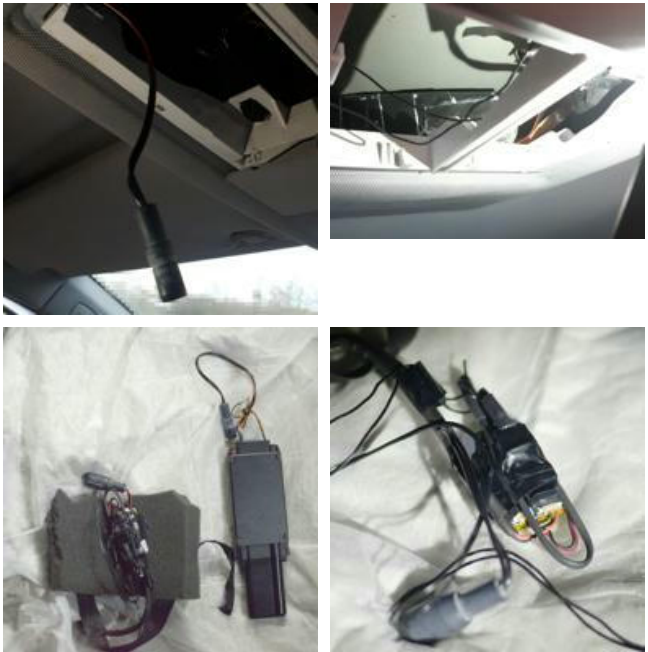
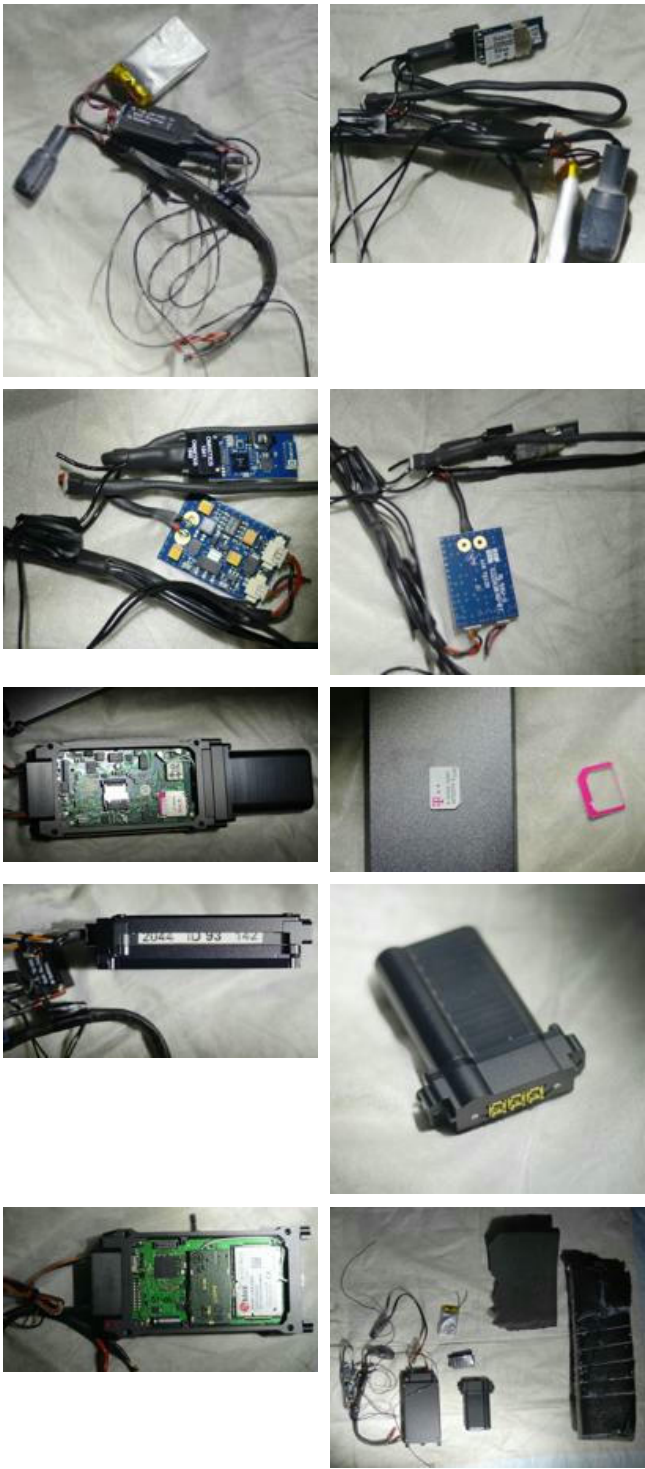
A **GPS tracker** and an **audio recording device** were found in a car. They were located **behind a panel of the front ceiling light**. They were connected by a power cable and drew their power from the supply line to the rear ceiling light. The GPS tracker contained, among other things, a GPS receiver “u-blox MAX-M8”, a card slot with a 16 GB microSD card, a cellular chip “u-blox LISA-U230” along with a SIM card, as well as a removable three-pin antenna module. The audio recording device contained a voltage converter, a 3.7 V, 550 mAh lithium-ion battery, and a small circuit board which included a 32 GB microSD card and the “NN01-104” antenna from the company Ignion (formerly “Fractus”). The audio recording device tapped into the microphone of the hands-free system, which was located behind a cover above the rearview mirror.

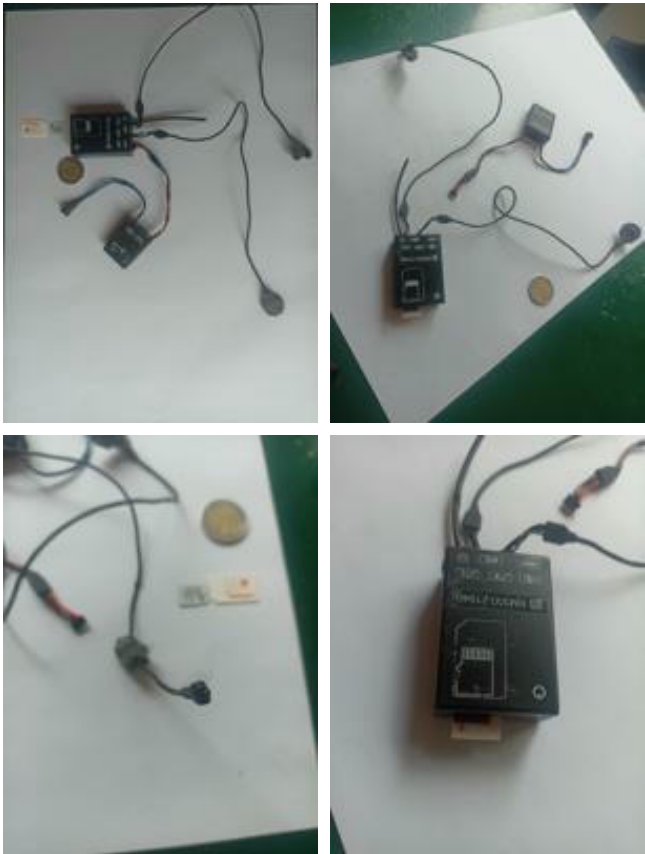
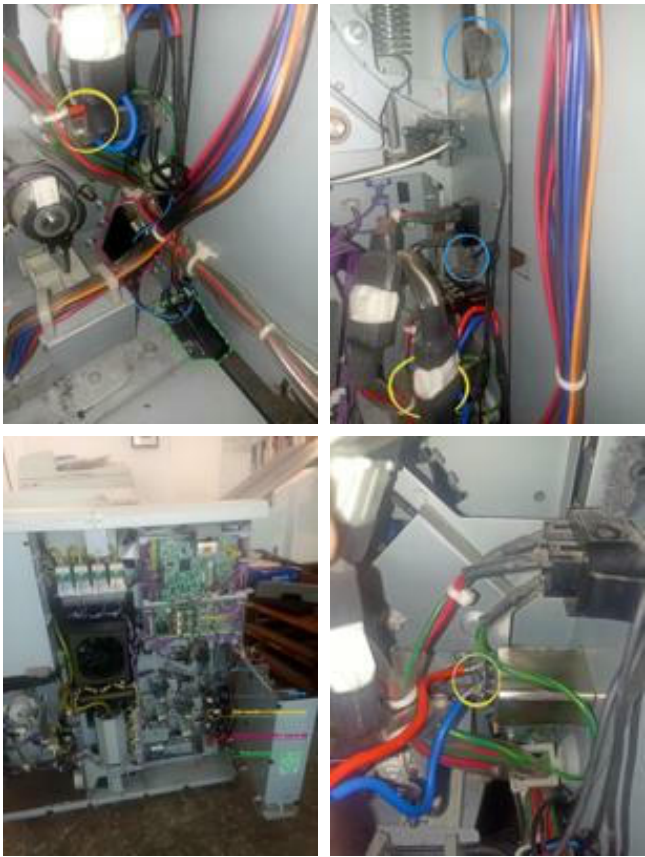
An **audio surveillance device** was found **in an anarchist library**. The device was hidden **inside the printer-copier of the library**. It included two microphones, an antenna, a transformer, a battery, a small box containing an electronic card, a 64 GB SD card, and a SIM card. According to the article that reported the discovery of the device, it was a surveillance device of model RB800 marketed by the Italian company **Innova**.

Blue: microphones; yellow: wires soldered to the power supply; pink: small box with SIM card + SD card; green: transformer.

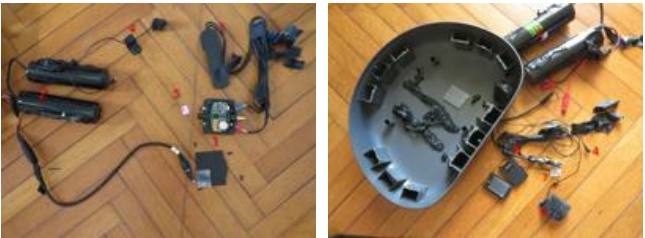
1: control unit; 2: batteries; 3: GPS antenna; 4: microphone; 5: SIM card. 2: the two batteries of the listening device; 4: microphones connected to the listening device; 6: dismantled listening device; 7: SD card.

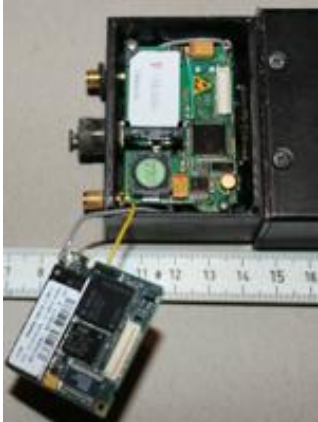
GPS tracker open with SIM card

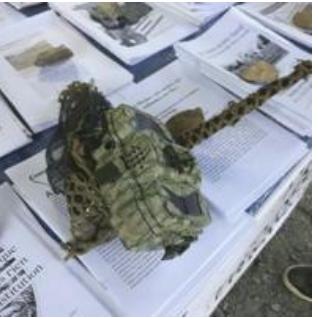
Three outdoor surveillance cameras were found outside, close to the venue of an event. They were located **along a 250m pathway leading to the venue**. Among them, two cameras of model “BOLYGUARD MG983G” were found **laying in the grass and in a bush, 80 centimeters above ground** and were covered by a kind of camouflage hairnet. The third camera, of model “RECONYX HYPERFIRE SM750”, was found **on a tree trunk, 1m20 above ground** and had a khaki color.

One of the two cameras of model “BOLYGUARD MG983G”

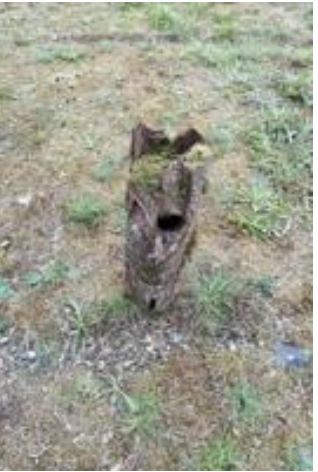
Four cameras were found outside a large area where people lived. They were hidden **near an access gate to the area, camouflaged in a fake tree log and fake stones**. They filmed continuously and were connected, via buried cables, to large batteries and concealed modems. The mention “Allwan” was visible on a label on a camera. The cameras were found on August 31, and appeared to have been installed right before a event organized in the area on August 29 and 30.

1: first camera group; 2: portal; 3: second camera group.
